International Maritime Pilots' Association (IMPA)
HQS Wellington, Temple Stairs, Victoria Embankment, London WC2R 2PN
Telephone: +44 20 7240 3973 Fax: +44 20 7240 3518
Email: office@impahq.org
Website: www.impahq.org

SAFETY CAMPAIGN 2010

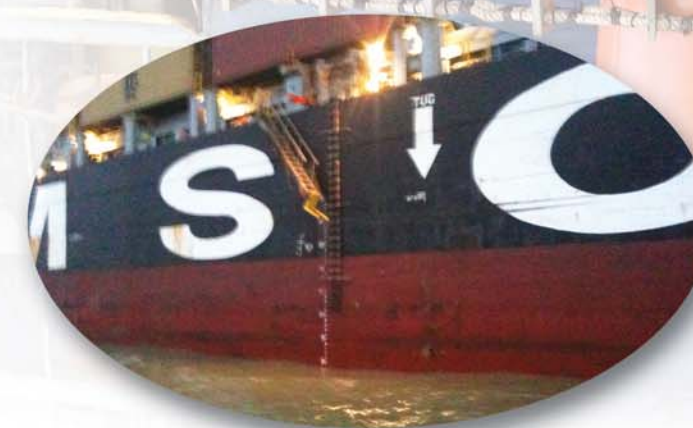
Ladders can injure vessel crews too! An A.B. on this vessel fell into the North Sea in October 2010 when this accommodation ladder platform collapsed under him. The man, wearing just a boiler suit with no life jacket or PPE, was retrieved by the Pilot Cutter. He was treated by Paramedics and returned to his ship, unscathed. The cause of the accident, according to the Master, was a failed weld, on a repair made a few weeks earlier.

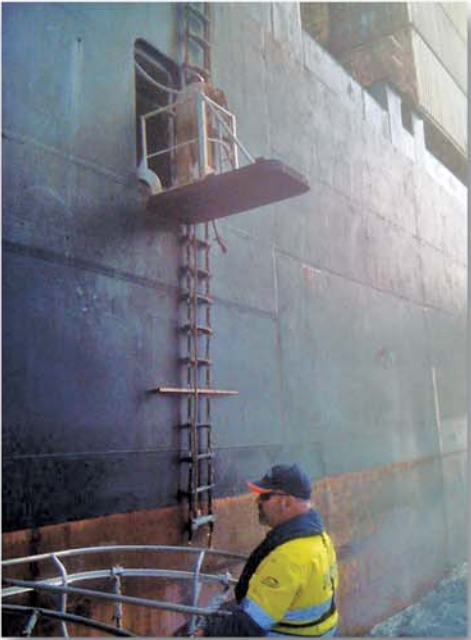
Is this a gunport or a door?

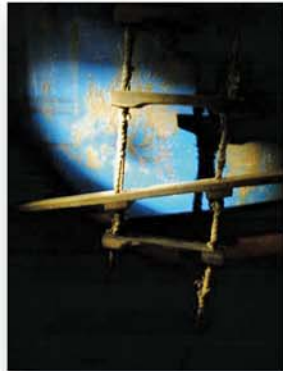
Ladder offered to pilot in Liverpool by the aptly-named vessel 'Great Chance'
