Report on the investigation into the grounding,
and subsequent loss, of the ro-ro cargo vessel

Riverdance

Shell Flats – Cleveleys Beach, Lancashire

**Report No 18/2009
September 2009**

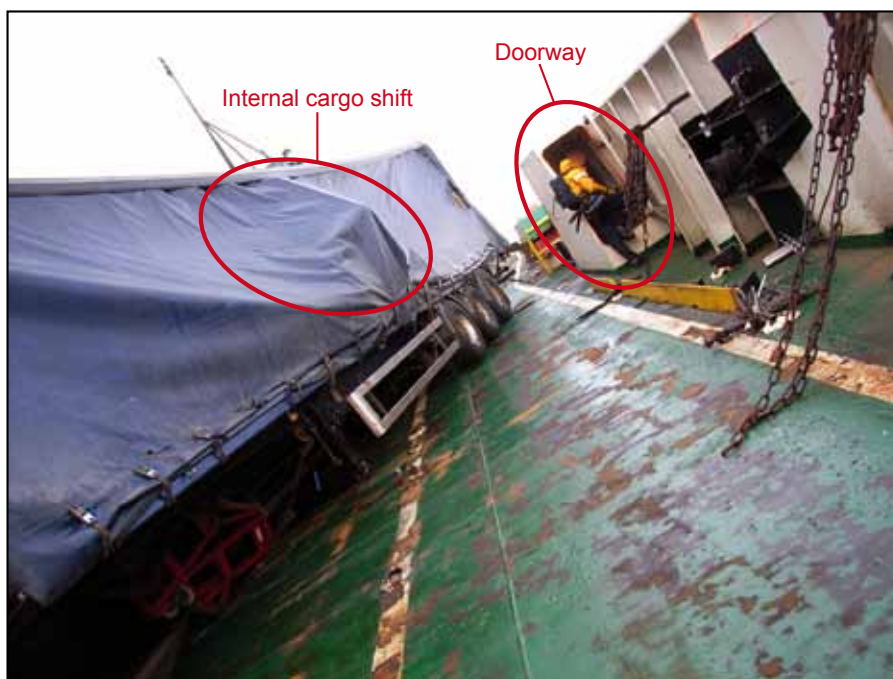
Figure 3

Cargo began to shift from within some trailers, and trailer units near the port side entrance to the main deck stairs shifted to rest against the bulwarks, blocking the chief officer's and AB's return path to the accommodation. Cargo inside one of these trailers shifted further (**Figure 3**), until it was resting against the weather door casing. Although very few trailers broke free of their lashings, cargo within several units broke loose, and the sound of moving cargo could be heard throughout the accommodation and in the engine room.

View of main access to main deck and trailer with indication of internal cargo shift. The cargo shift is in line with the access door and when listing to port may have hampered attempts to close the door

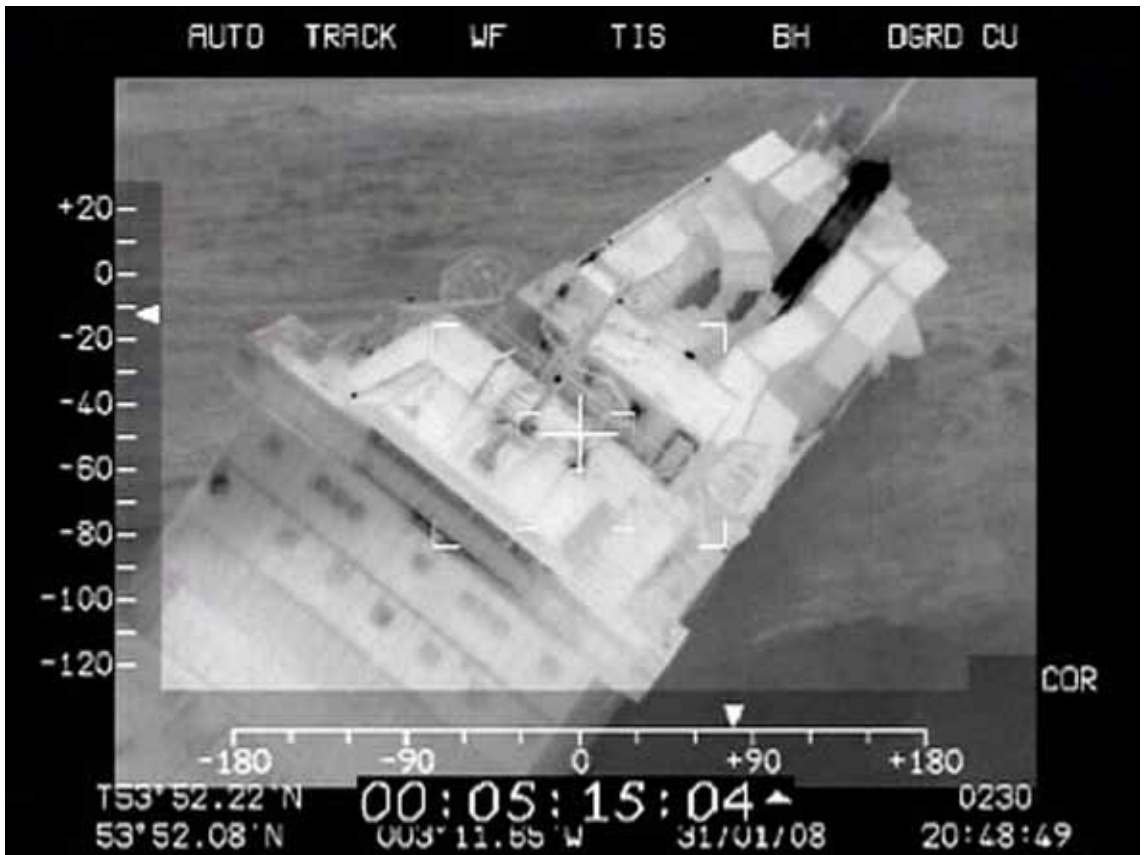
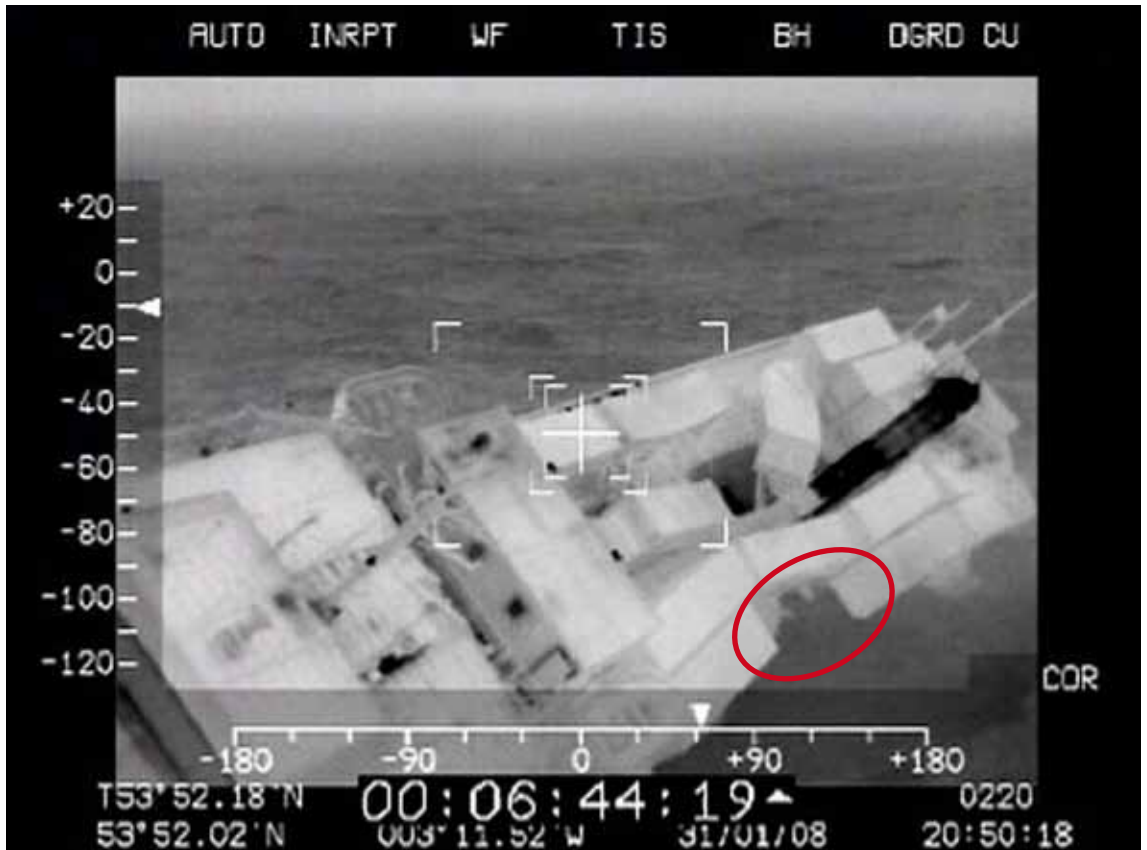
Further reports to Liverpool coastguard followed; at one stage, the list was reported to be as much as 60° to 70°. However, subsequent analysis of the video taken from RAF rescue helicopter, R122, showed *Riverdance* to have a median list of about 35° (although during extreme rolling, angles of 50° were observed) (**Figures 5a and b**).

Video still from R122: Initial encounter with *Riverdance*

Note: seas breaking on the upper deck

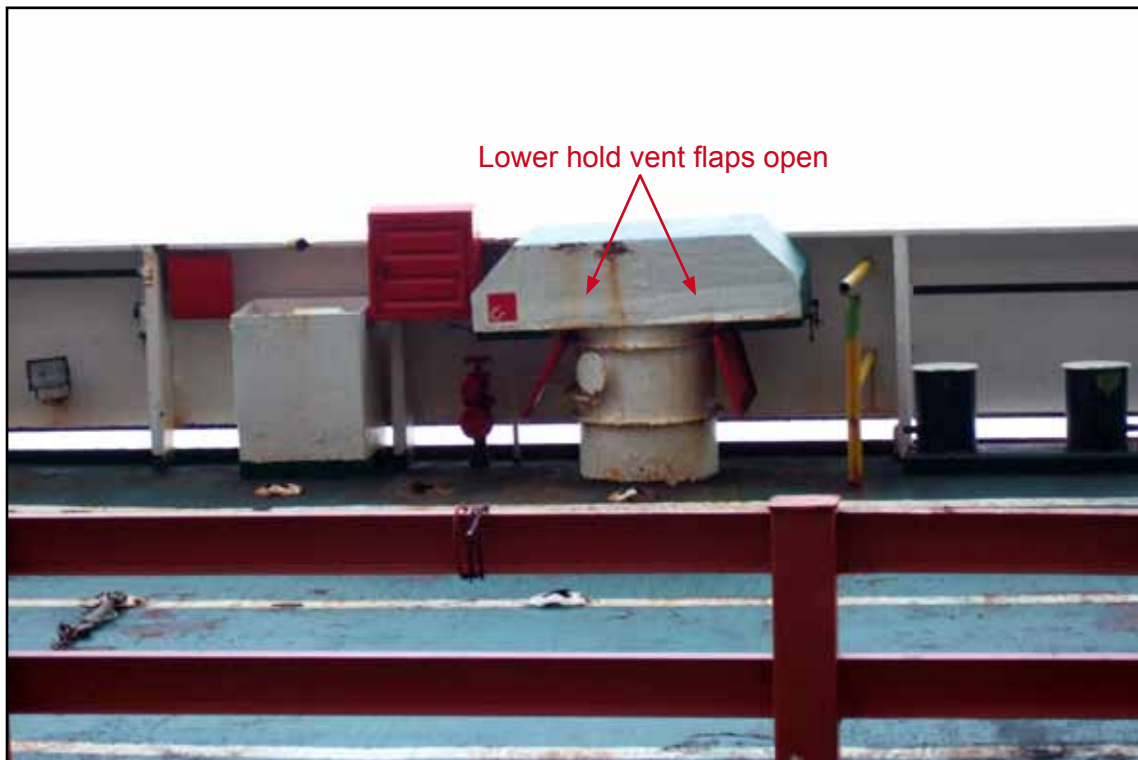
Figure 6

Video recording taken from the rescue helicopter confirmed that during this period, the port side weather deck door and lower hold vents, positioned near the ship's side, were repeatedly submerged by breaking waves as *Riverdance* rolled to port. Although it is understood that the chief officer did manage to close the weather deck door prior to descending to the engine control room, the lower hold vent flaps were found in the open position when *Riverdance* was examined after the foundering (**Figure 6**).

Port side lower hold vent (after grounding)

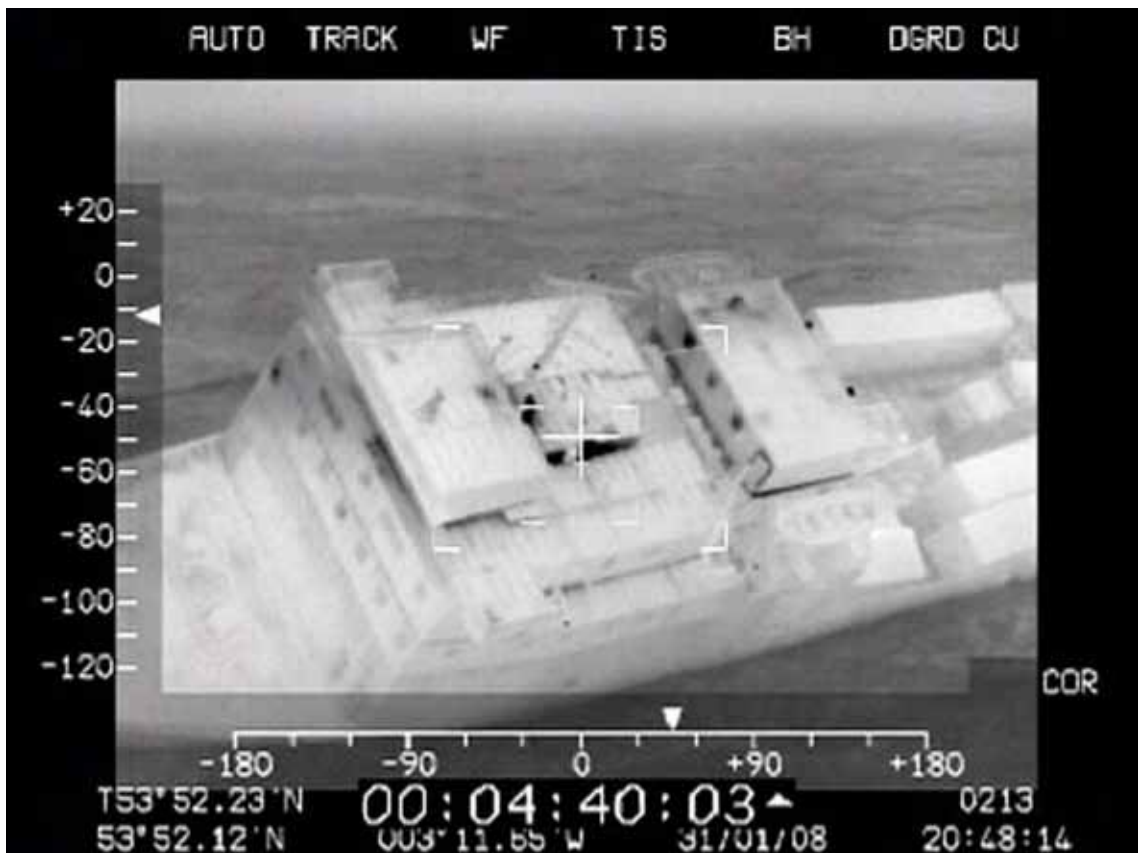
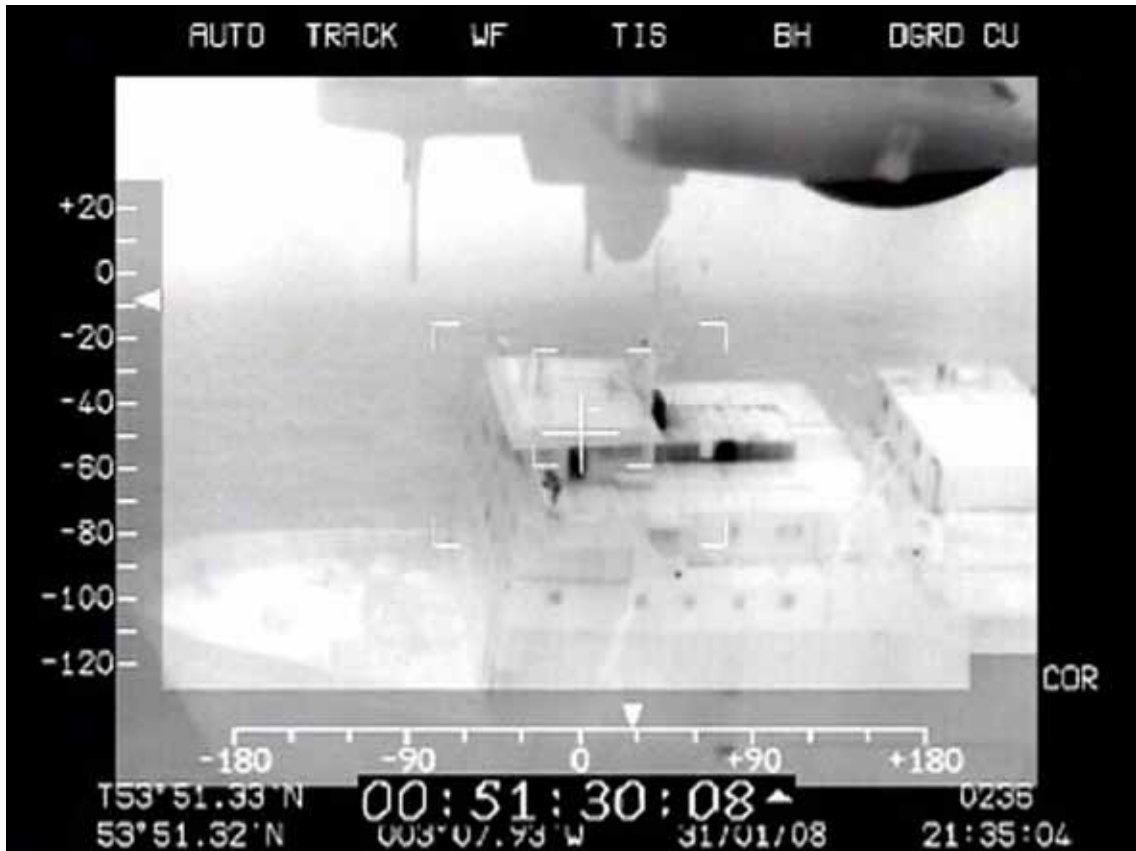
Figure 7a

Just before the engine room was abandoned, one of the volunteers had started the heeling pump, and left it running in an attempt to reduce the port list. Further video taken from rescue helicopter R122 shows the list reduced to about 20° during the next 30 minutes (**Figures 7a and b**).

At 2100 - list approximately 35°

At 2130 - list approximately 20°

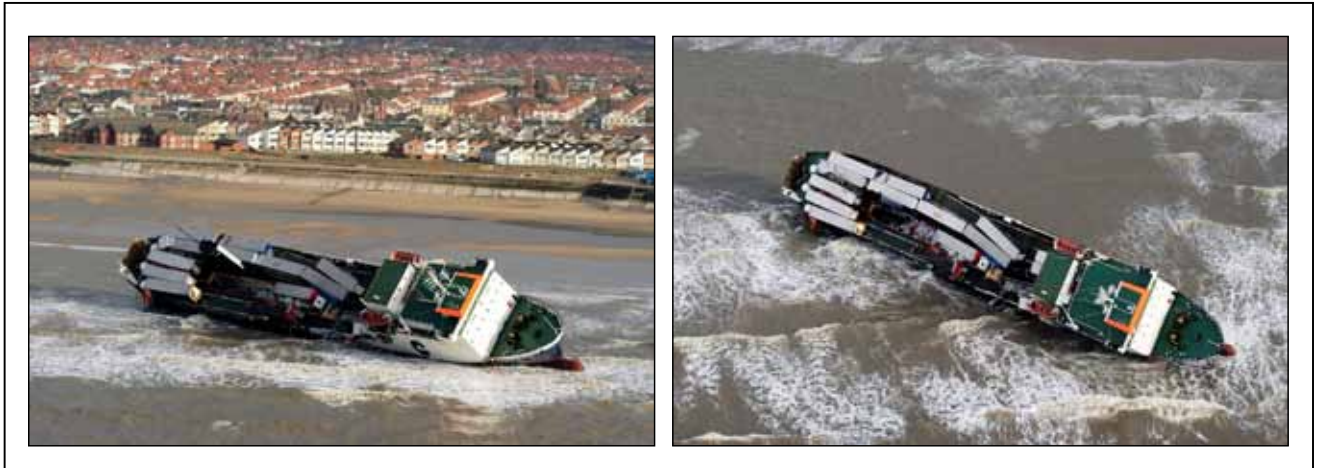
Once the attempts to refloat *Riverdance* were suspended, she began to roll as the waves crashed into her side. Several rolls were felt to starboard, against the wind and sea. These were followed by a lurch and a quick roll, before *Riverdance* settled over on her starboard side at an angle of about 30° (**Figure 9**). Her final grounding position was close to the sewer outfall pipe, which was subsequently found to have suffered slight damage.

Riverdance aground on the morning of 1 February 2008

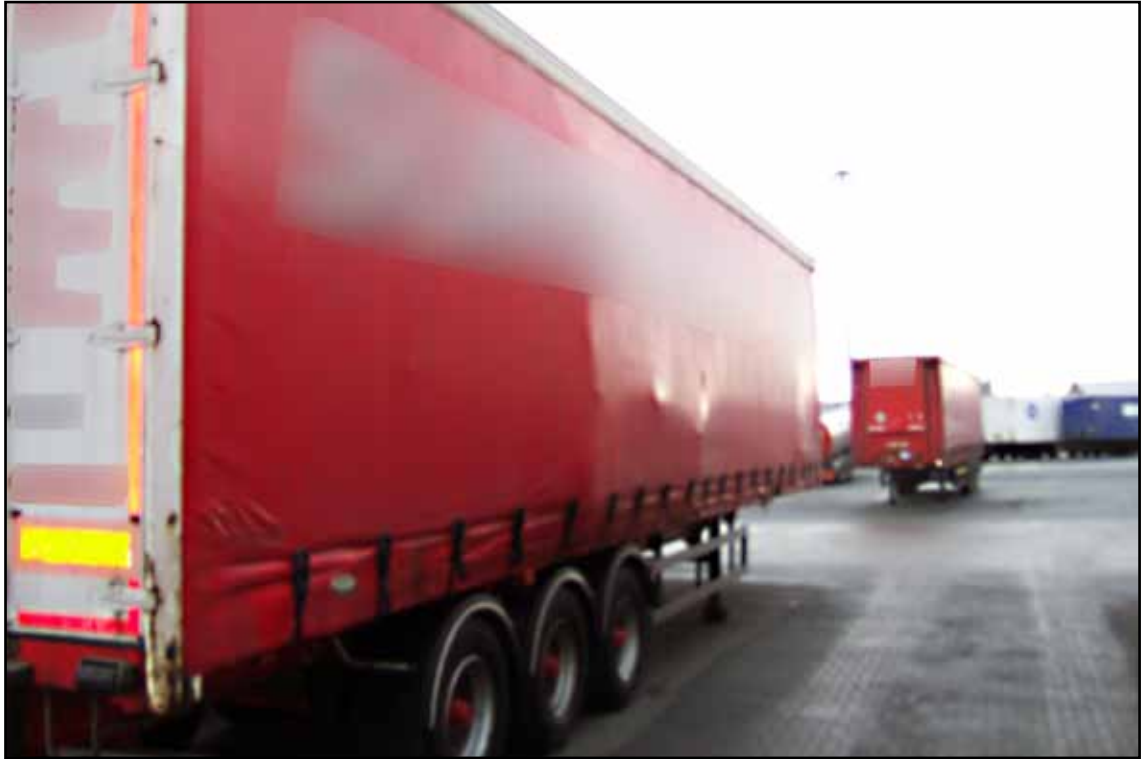
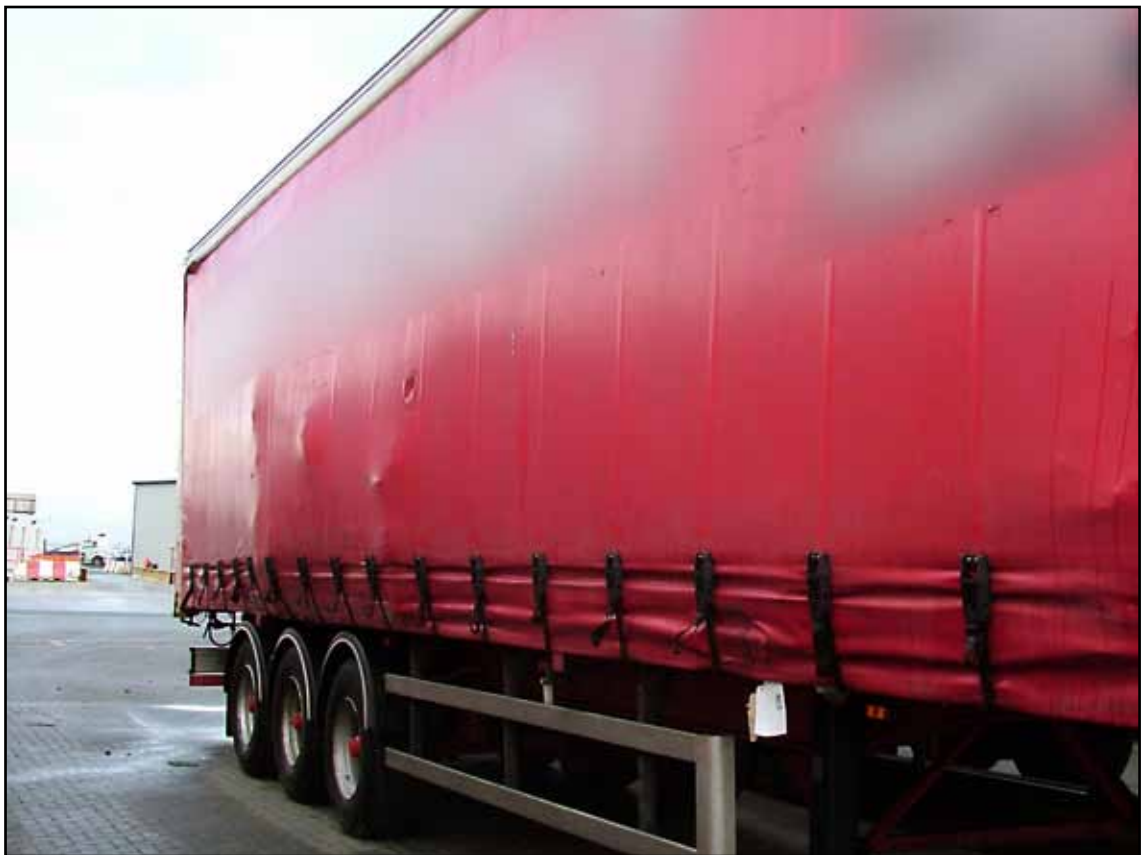
Examples of tautliners with bulging sides prior to shipment

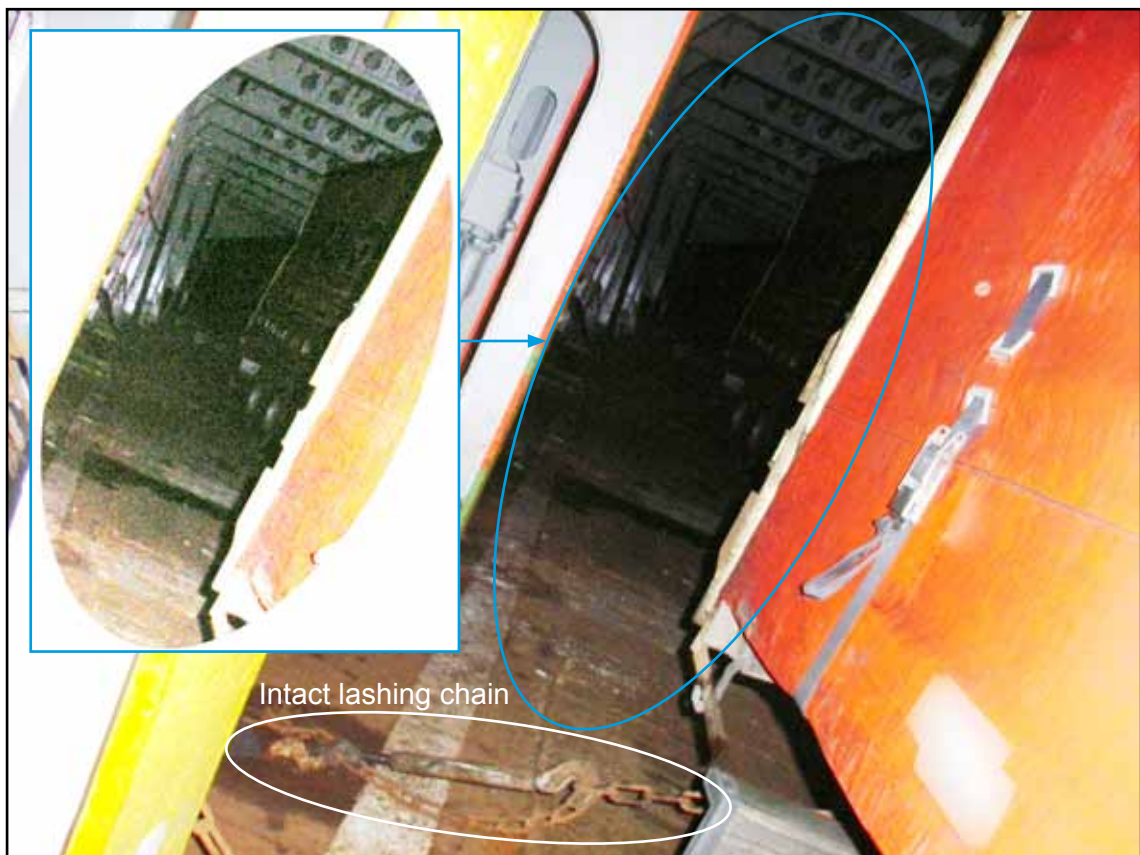
Figure 11

The trailer lashings were then re-checked at 30 minute intervals while *Riverdance* was on passage, with only minor tightening required. Most of the lashings held securely even when *Riverdance* was listed over to extreme angles (**Figure 11**).

Trailers still secured on the main deck after the grounding

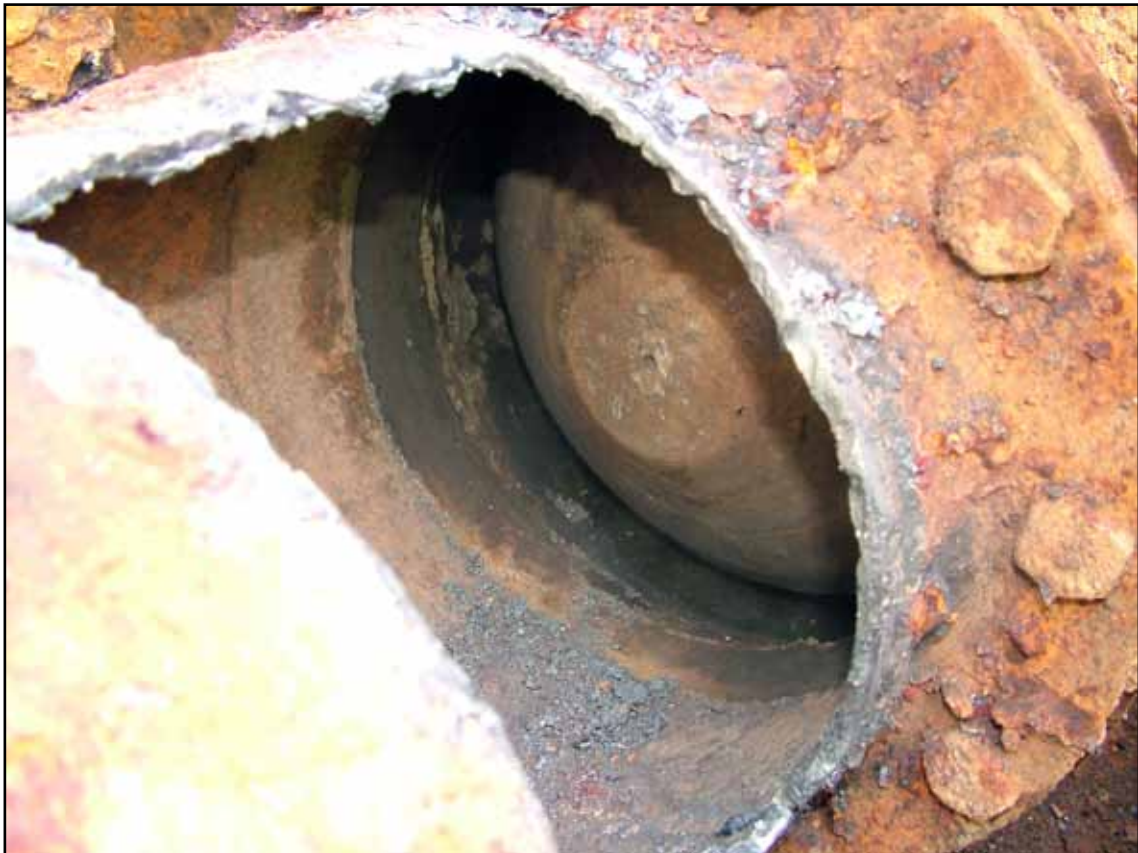
Figure 14a

During the vessel’s demolition process on Cleveleys Beach, some 6 months after the grounding, the non return valves were inspected and both of the upper, discharge side valves were found to be seized in the open position (**Figures 14a and b**).

Port non return valve not sealed

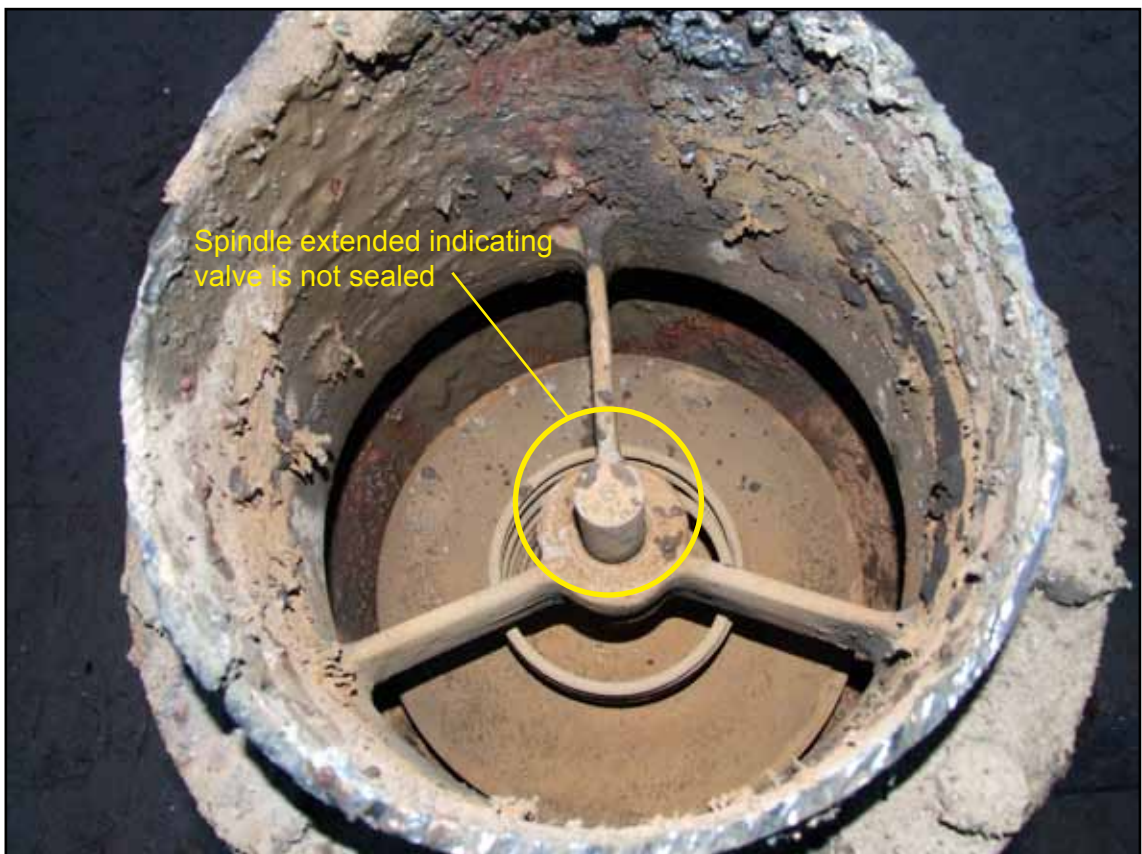
Figure 14b

Spindle extended indicating
valve is not sealed

Starboard non return valve

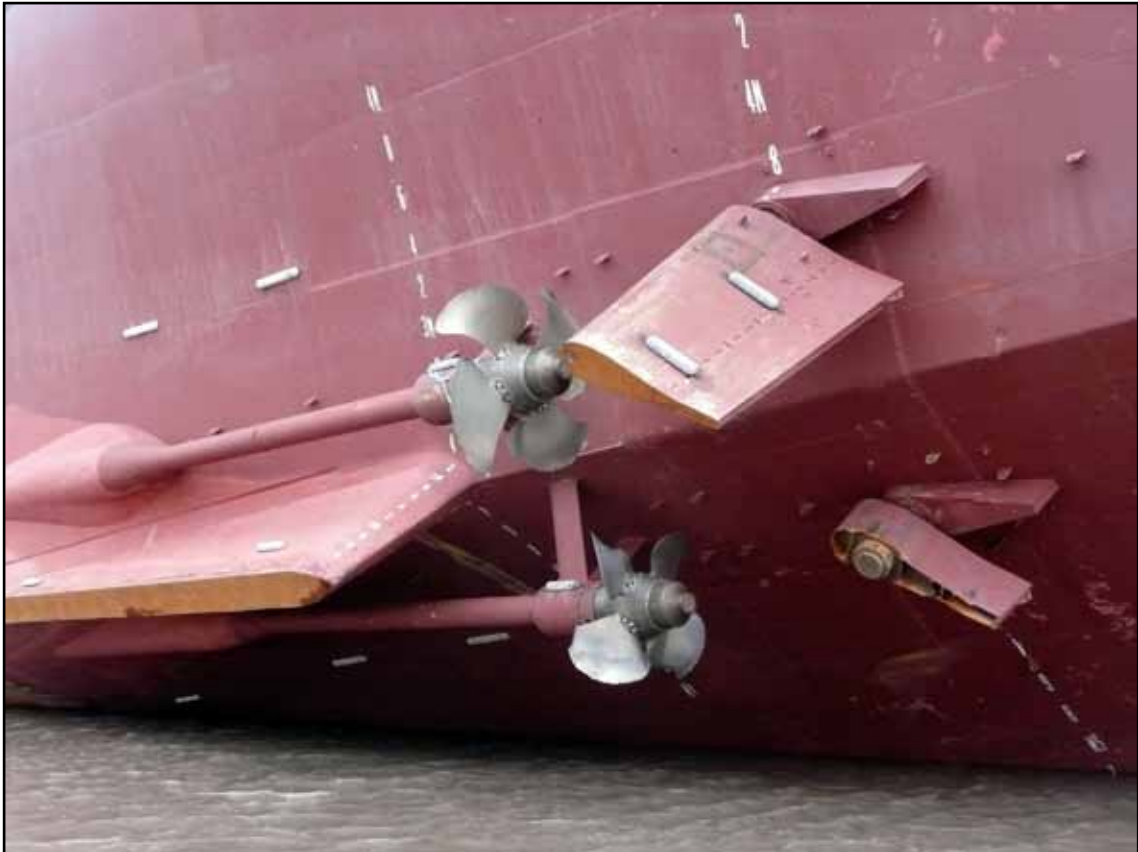
Damage sustained to *Riverdance's* CPP and starboard rudder

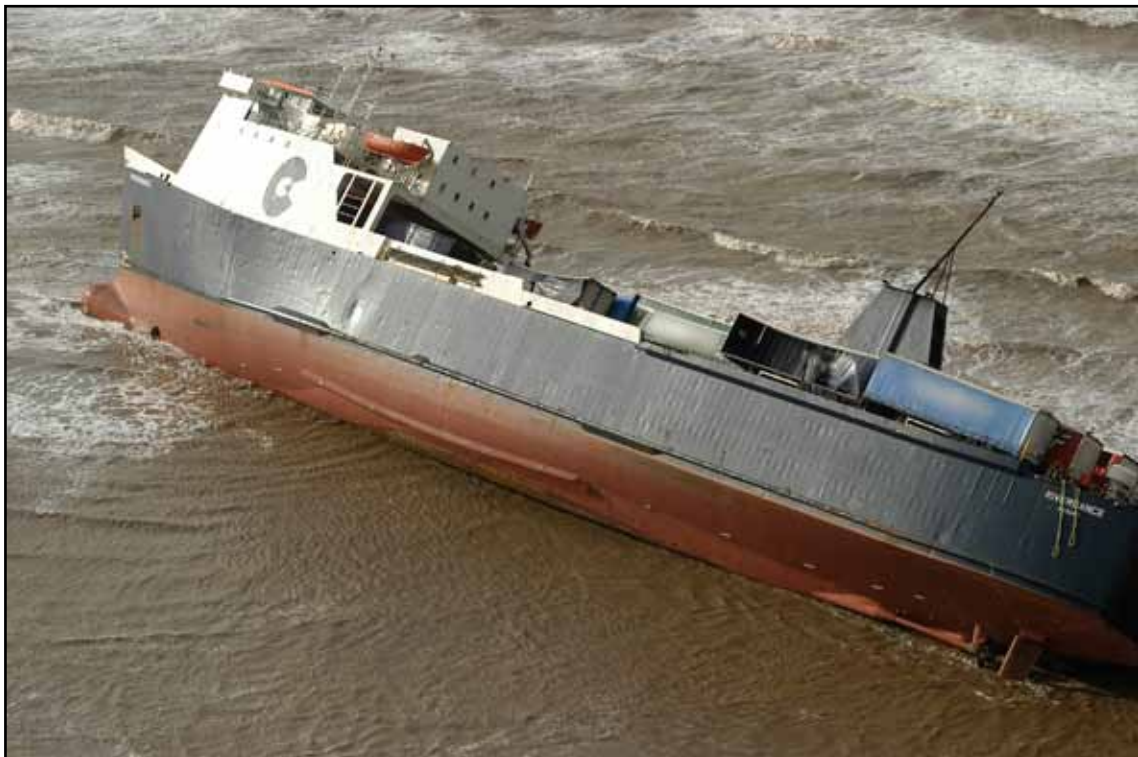
Consequently, when *Riverdance* finally came to rest on the beach at Cleveleys, her hull appeared intact and sound (**Figure 16**). However, the effects of bad weather, during the following days as the vessel lay on the beach, together with the continual pounding and effects of wave action on the hull, eventually laid her open to the sea.

Vessel aground with no apparent damage to ship's port side or hull

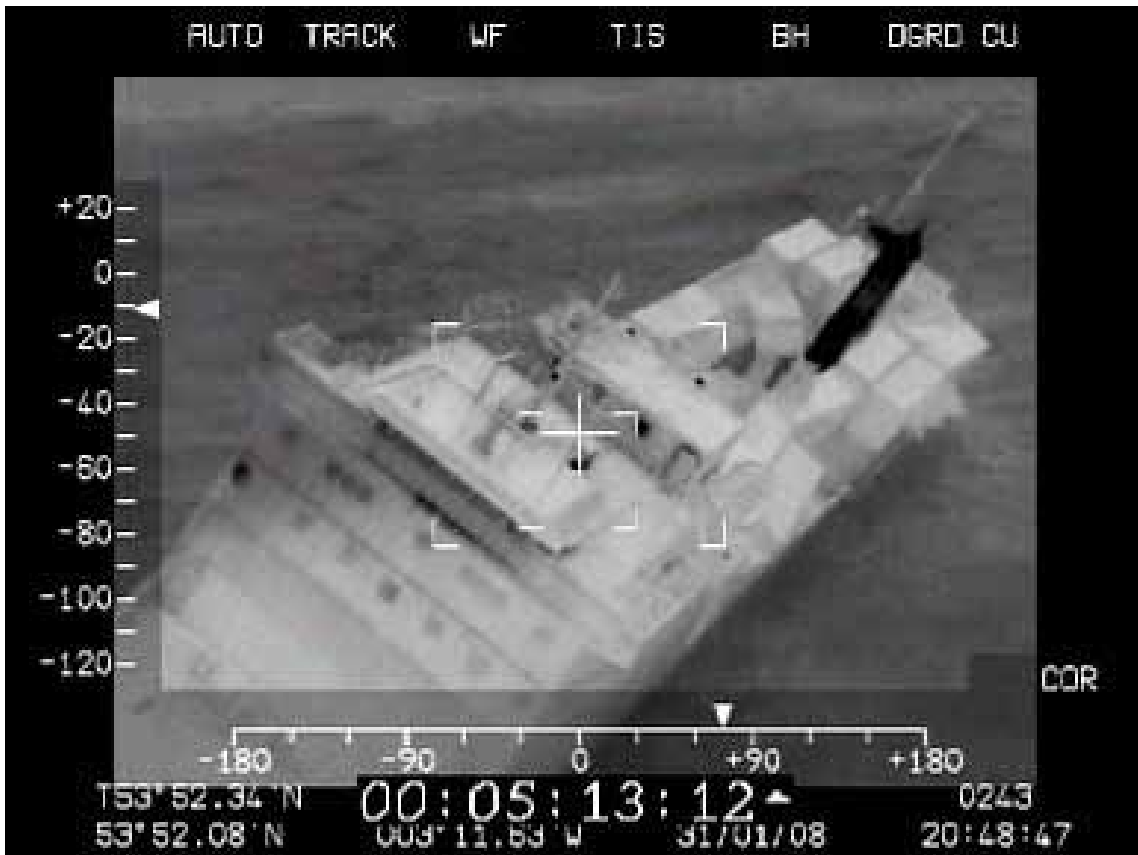
Two stills from RAF video showing majority of trailers still held in, or close to their original position

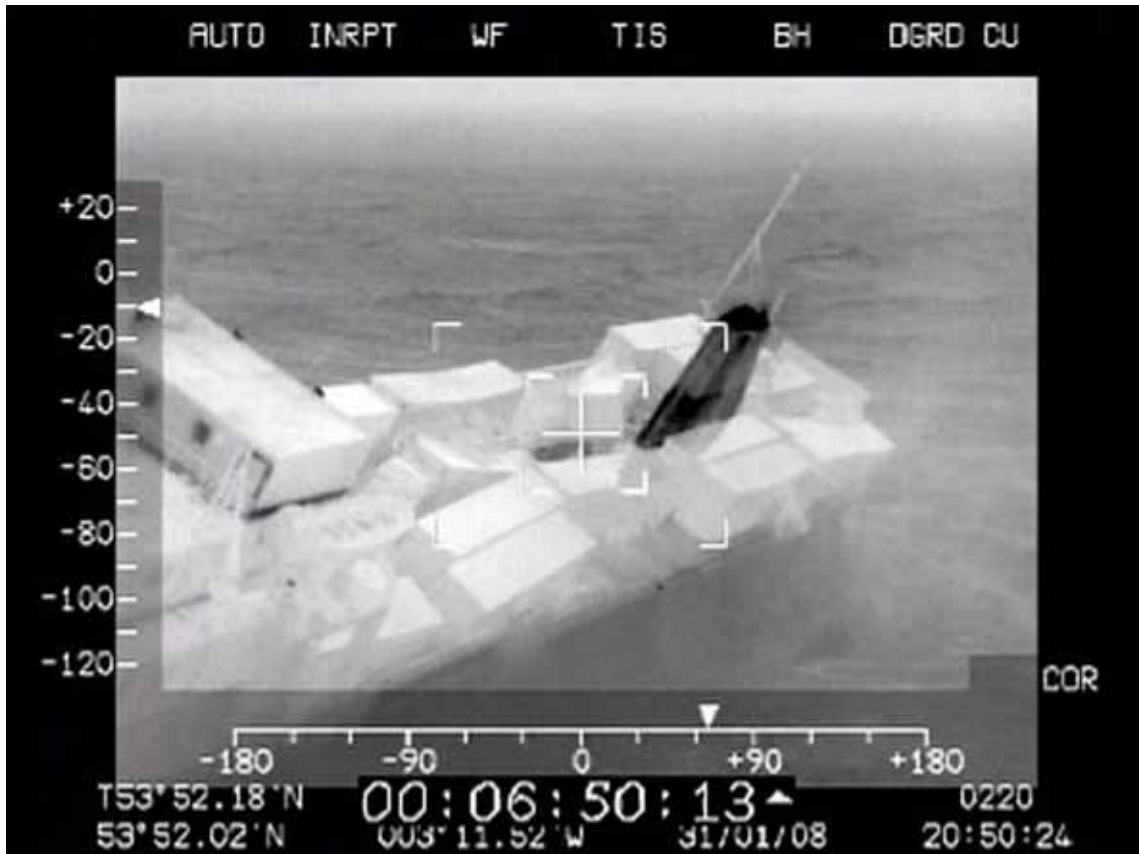
Still from RAF video, showing upper deck cargo disposition

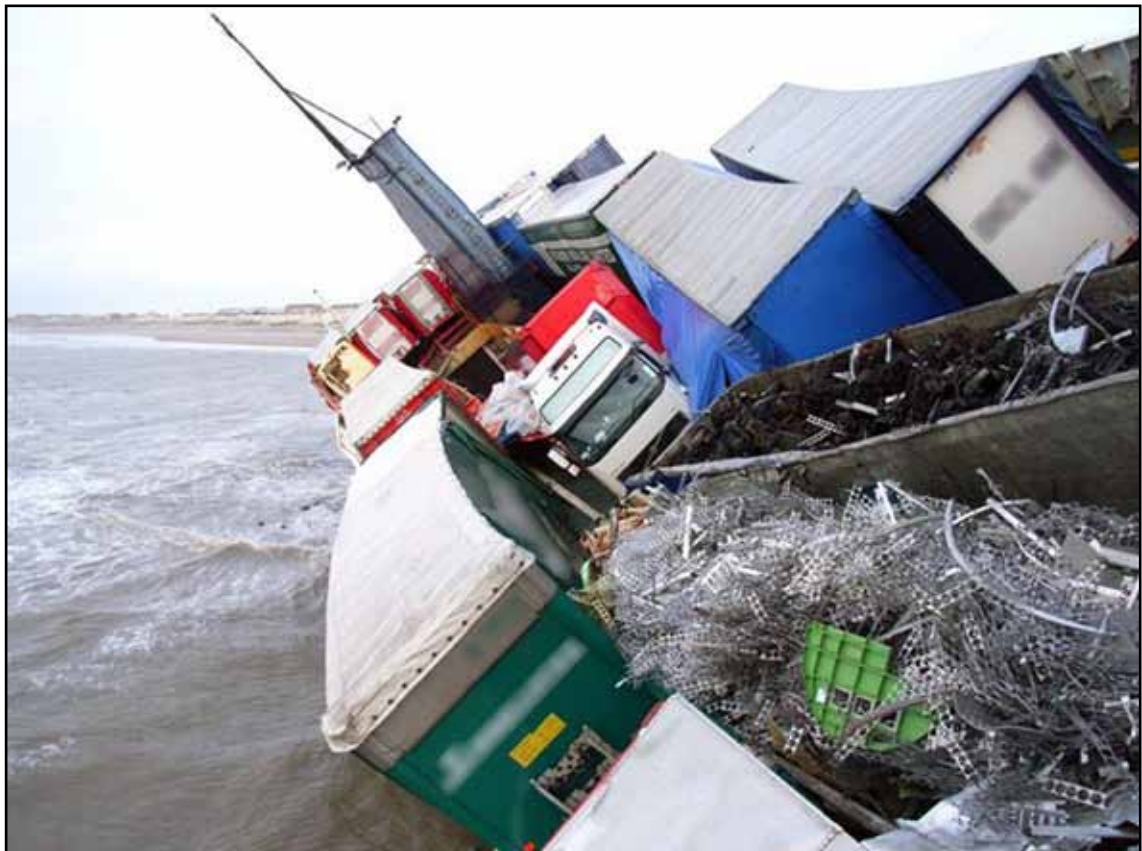
Figure 22

Upper deck looking aft

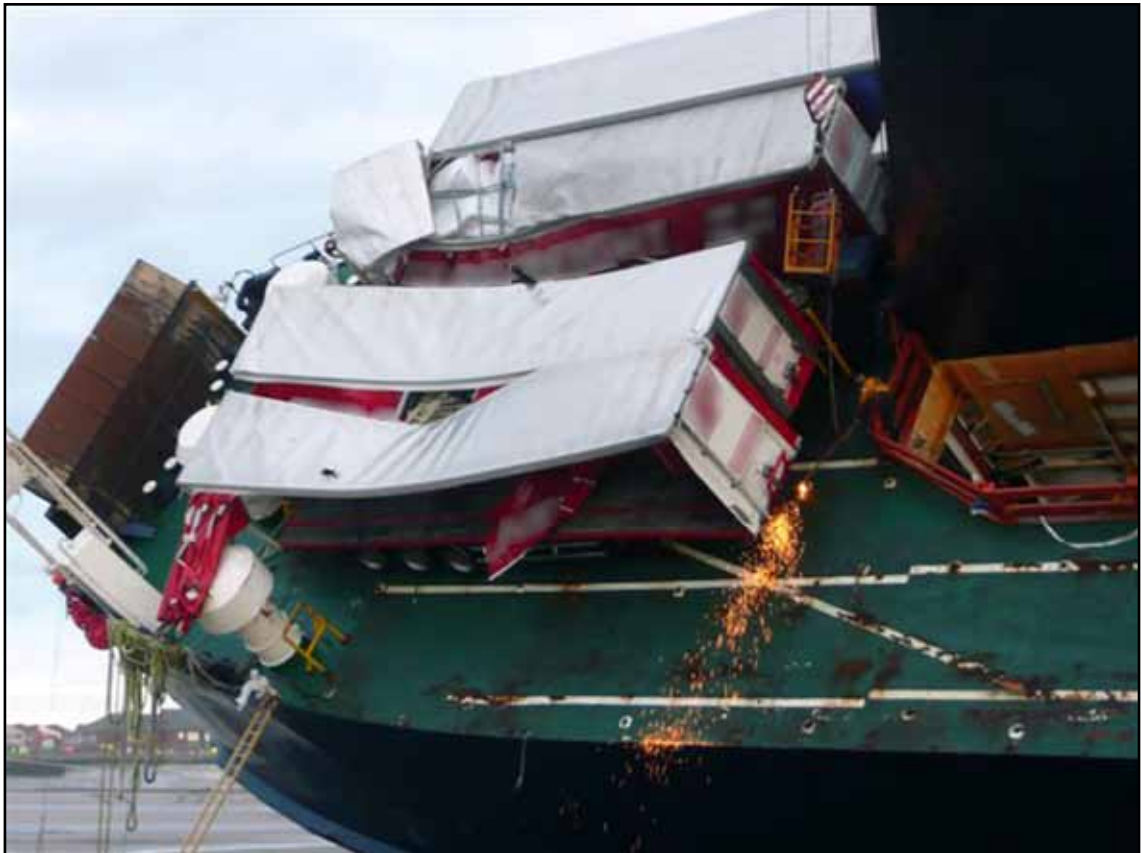
Figure 23

Although MAIB inspectors were unable to gain access to *Riverdance* to accurately assess the amount of cargo shift that had taken place on the main deck, it was apparent from witness statements that most trailer lashings had held. In fact, several trailers remained securely lashed even when the list increased during the salvage operation and *Riverdance* was laid over to large angles on her side (**Figure 23**).

Aft deck - trailers remain secured at large angle of heel

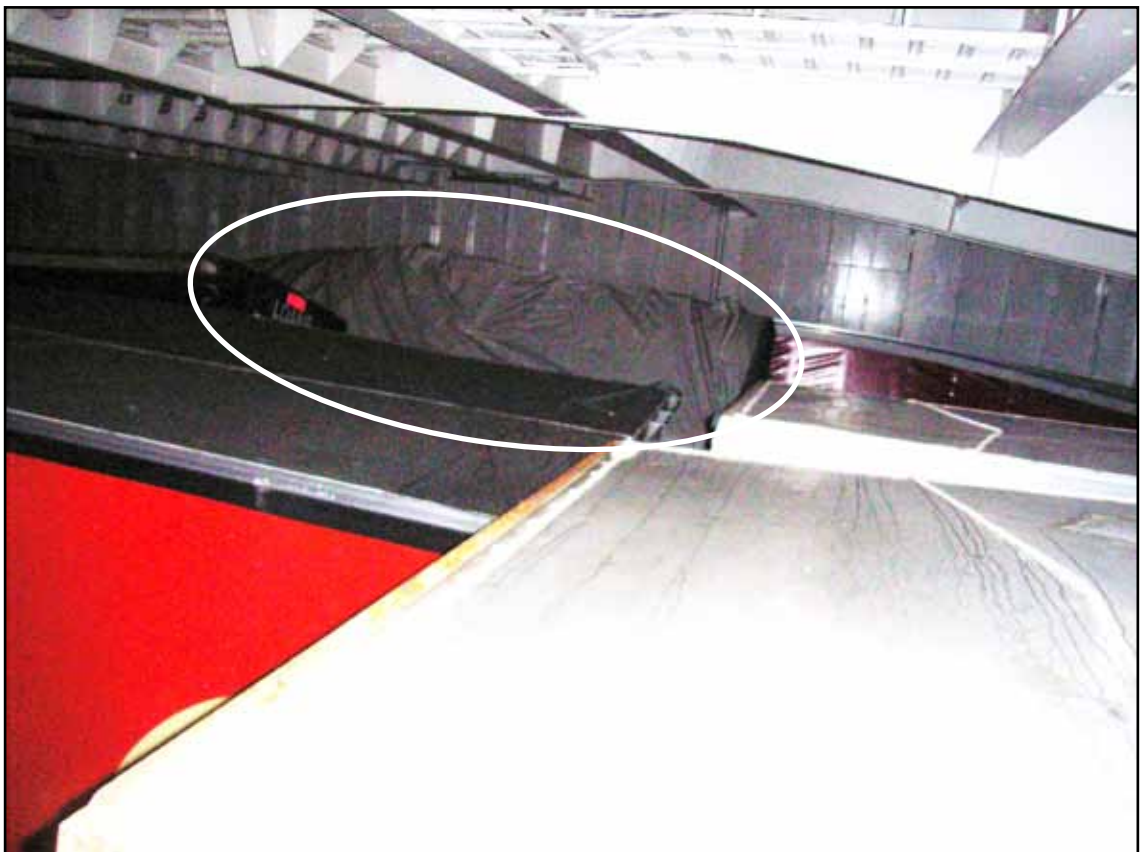
Figure 24b

The few photographs available of the main deck after the final grounding also show little evidence of trailers shifting or of cargo having been lost from the trailers themselves (**Figures 11, 24a and b**). Most show taughtliners still in the stowed positions, with no indication of cargo having broken through the curtain sides.

Trailers still secured on the main deck after grounding - note the flatbed with load still secured (circled)

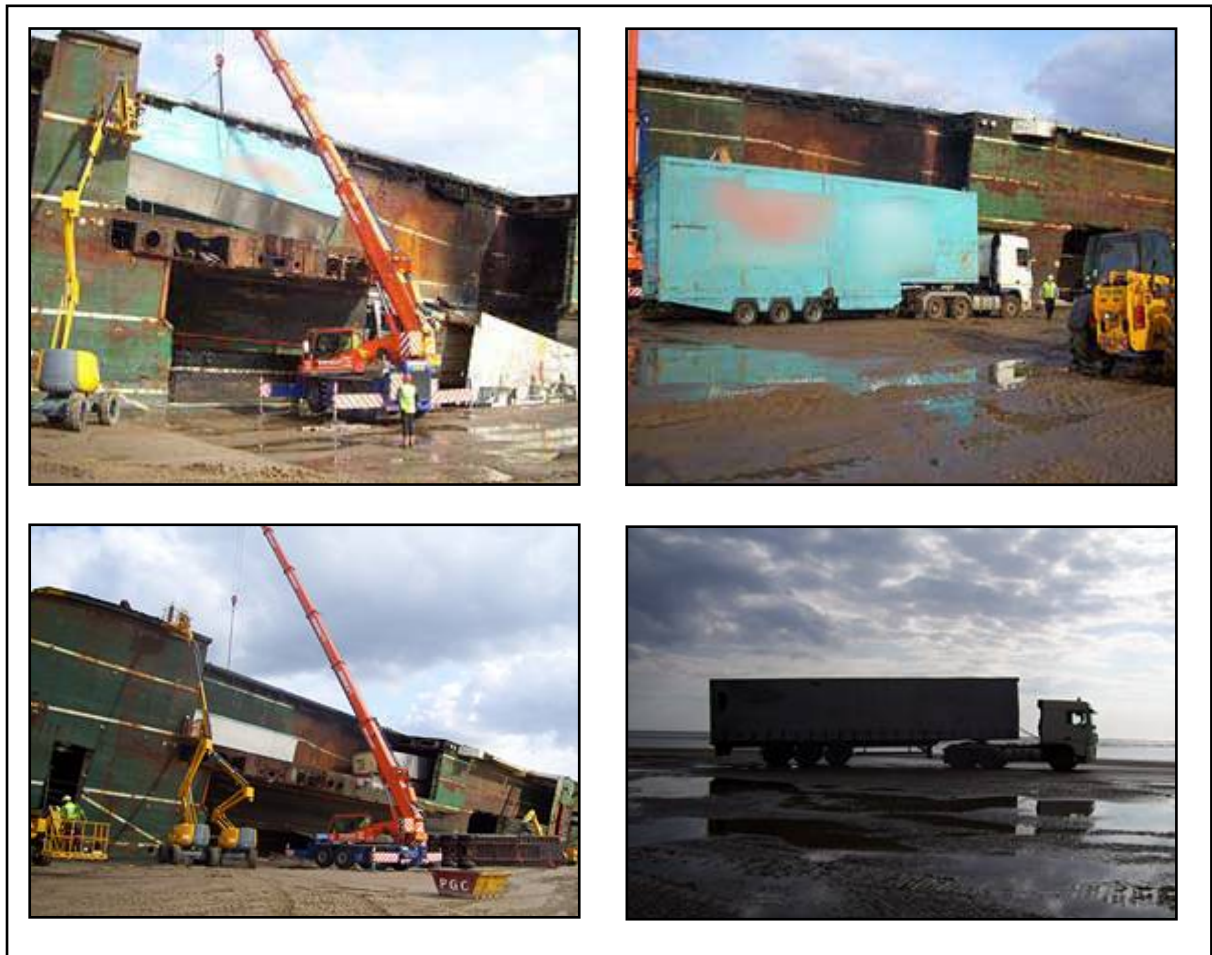
During the final breaking up of *Riverdance*, a significant number of trailers were removed from the main deck, substantially intact (**Figure 25**). It would appear that within the confines of the main deck, any trailers that did break free were prevented from moving very far, by the adjacent trailers or parts of the ship's structure. This would have limited the amount of weight that could have shifted to cause the vessel to list.

Photographs taken during demolition showing trailers being removed substantially intact

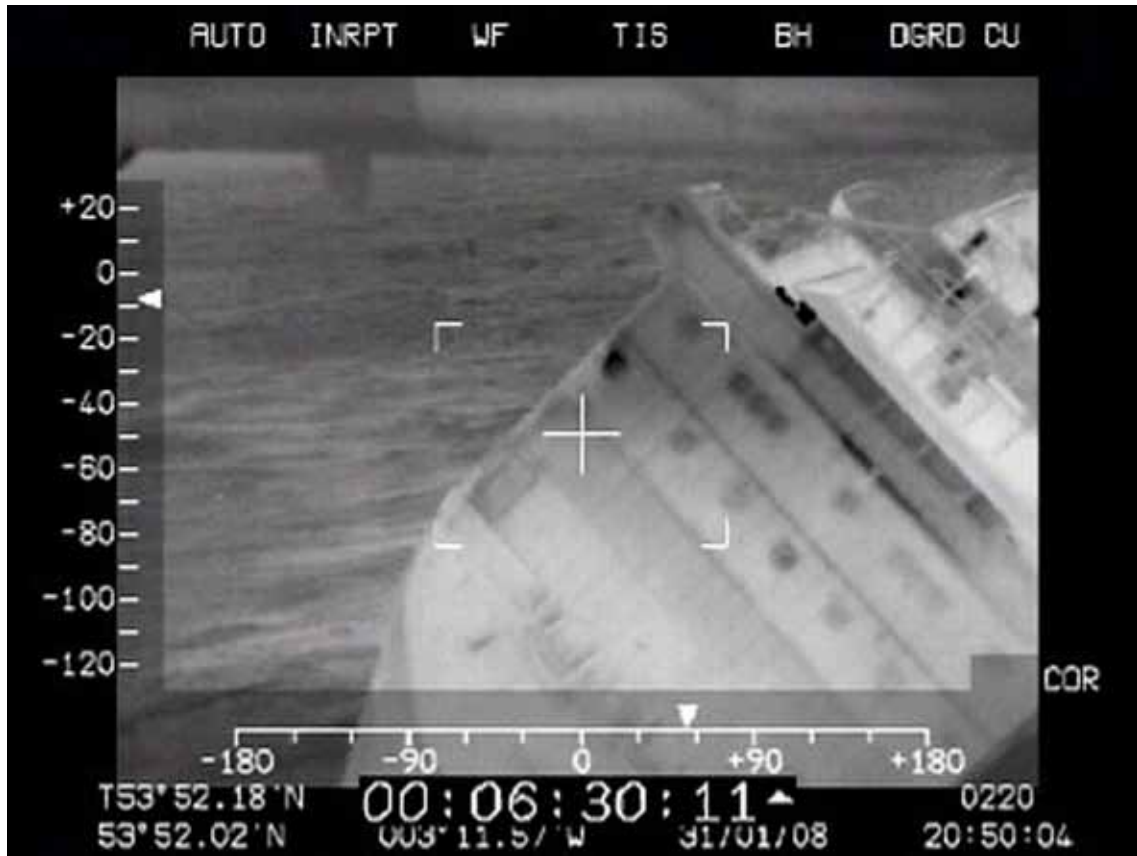
It is not possible to establish with certainty the precise reasons why *Riverdance* experienced the excessive lists on 31 January 2008. However, it is probable that a combination of the scenarios discussed above existed that night. What is known is that the list of 35° experienced on the exit from the sudden turn to starboard is unlikely to have been caused by the effect of cargo shift alone (**Annex 1, Section 3.10.3**).

RAF video showing median list of 30 to 40°

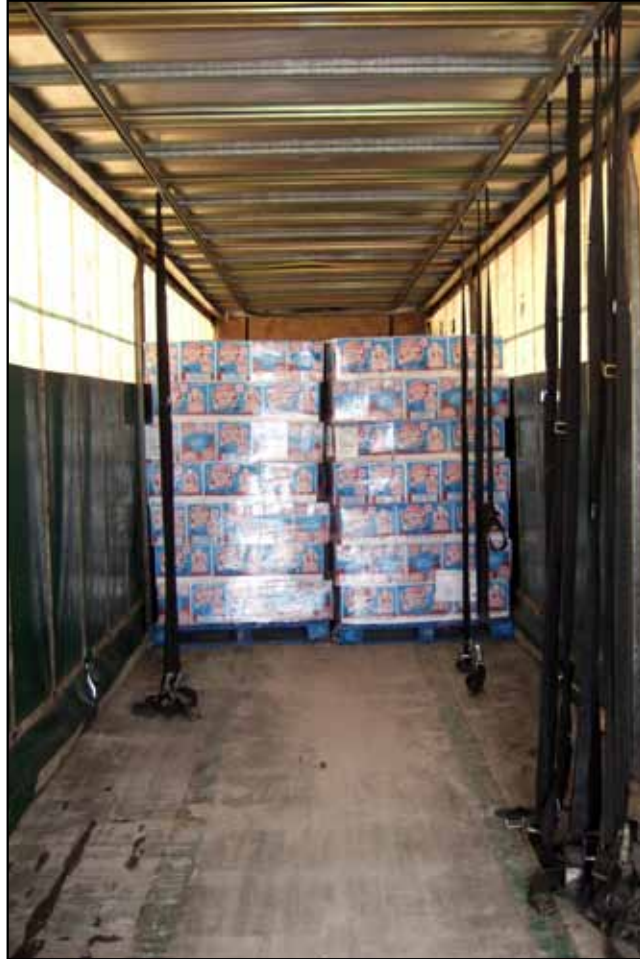
Figure 28

Securing arrangement within a "taughtliner"
Note: cargo is not secured down onto the trailer deck

There is a clear need for further work to be done to ensure that shippers and hauliers recognise the importance of stowing and securing the contents of trailers destined to be transported by sea and adhere to the available guidance on this issue.
