Report on the investigation of
the shift of an articulated road tanker on board the
roll-on roll-off high-speed sea service cargo ferry

Stena Voyager

in Loch Ryan

Report No 21/2009
October 2009

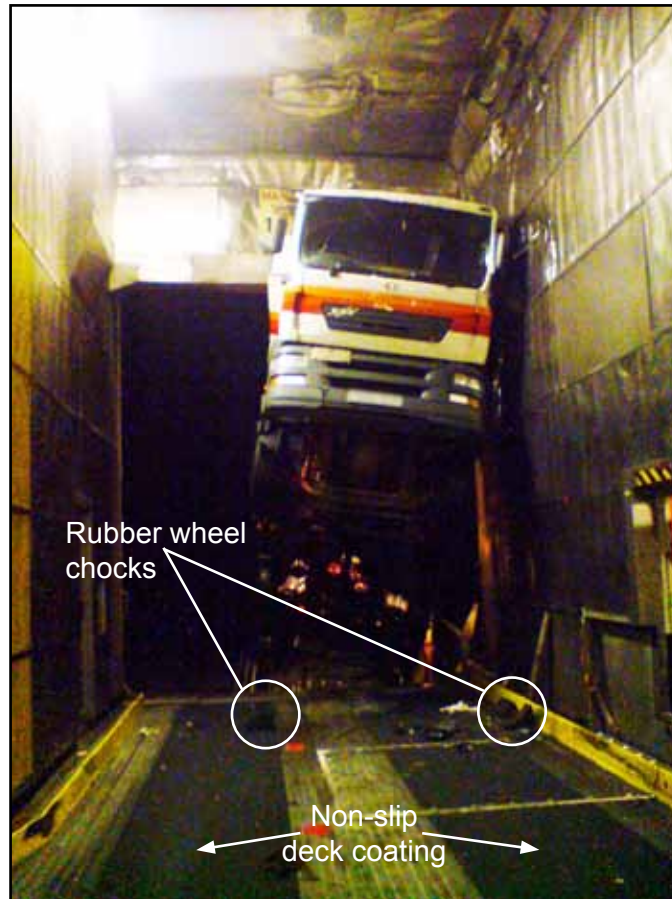
Figure 4

The senior deck assistant and deck assistant immediately went to the aft end of lane number one, where they saw the road tanker's tractor unit raised off the deck and wedged into the top outboard corner of the stern door opening (**Figure 4**). The aluminium door had been lost overboard and the vehicle's semi-trailer was hanging off the back of the ferry directly above the two port water jets. The senior deck assistant used his hand-held VHF radio to alert the bridge of the situation, and the chief engineer confirmed that a 'doors open at sea' alarm had activated. The master immediately stopped the vessel.

Photograph of road tanker tractor unit taken immediately after the accident

One rubber chock was placed on each side of the two wheels on the semi-trailer's rear axle. Four rubber chocks were photographed close to number one stern door shortly after the accident (**Figure 4**).

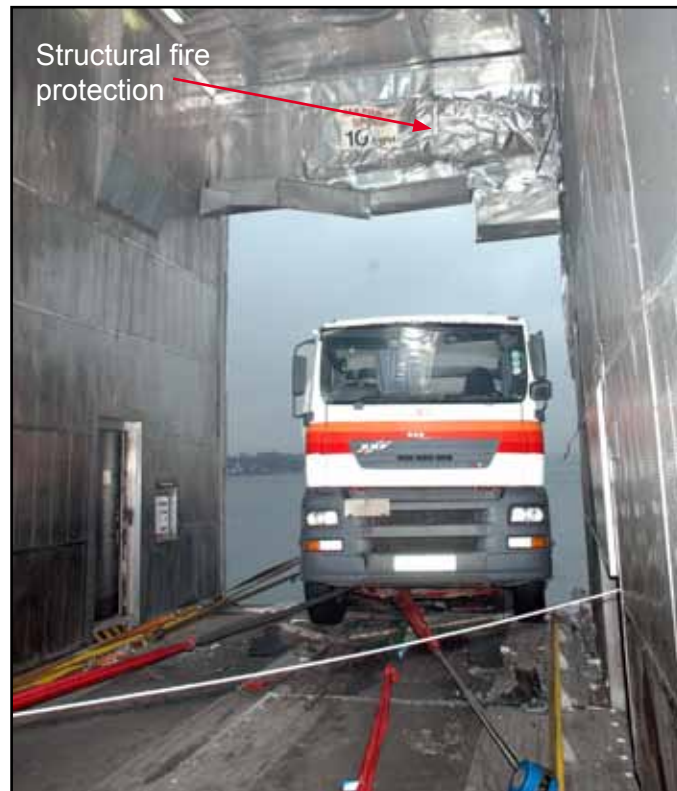
Figure 5

Prompted by the first officer, the deck crew confirmed they could not see anyone in the vehicle's cab and also advised that it was too dangerous to attempt to make it secure. At 2105, *Stena Voyager* was stopped off Leffnol Point (**Figure 3**) to allow the master an opportunity to fully assess the situation and for the vehicle to be stabilised. At 2107, the tractor unit dropped steadily to the deck and the semi-trailer rested on top of number two water jet. The deck crew immediately lashed the cab to the deck (**Figure 5**).

Road tanker tractor unit secured to the deck

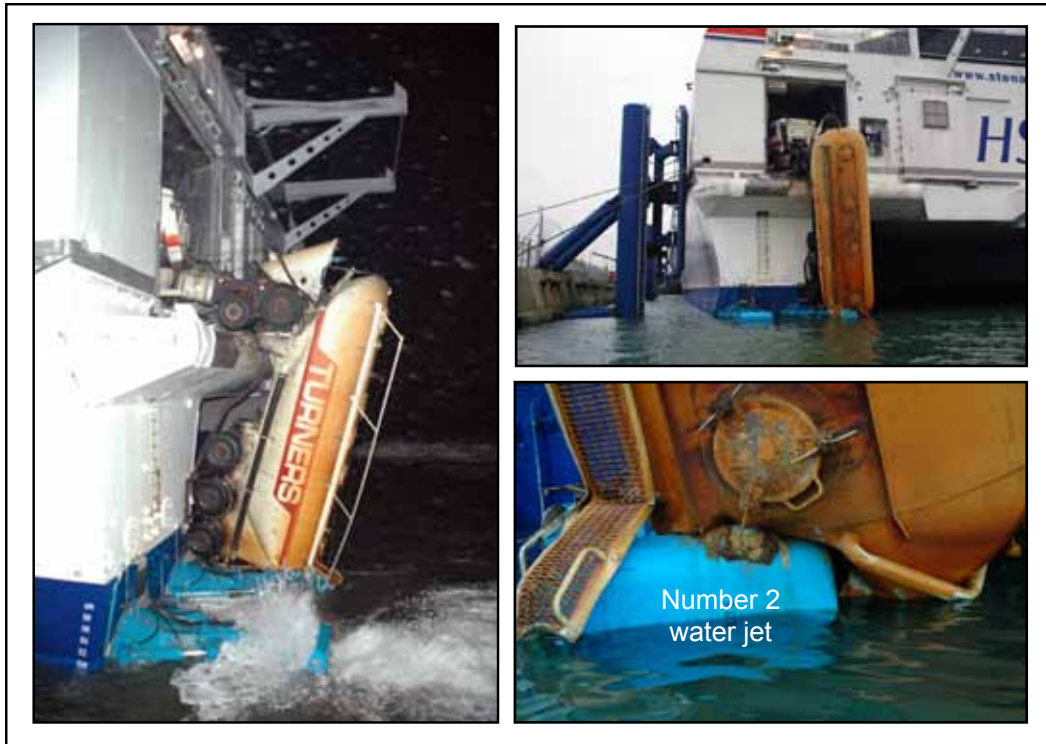
Because the semi-trailer was hanging over the stern of the vessel (**Figure 6**), it was not possible to use the linkspan, so at 2241 the vessel berthed alongside the quay, port side to. It was only then that the master realised the stern door had been lost overboard and alerted the coastguard, which immediately issued a navigation warning.

Road tanker semi-trailer resting on top of number two water jet

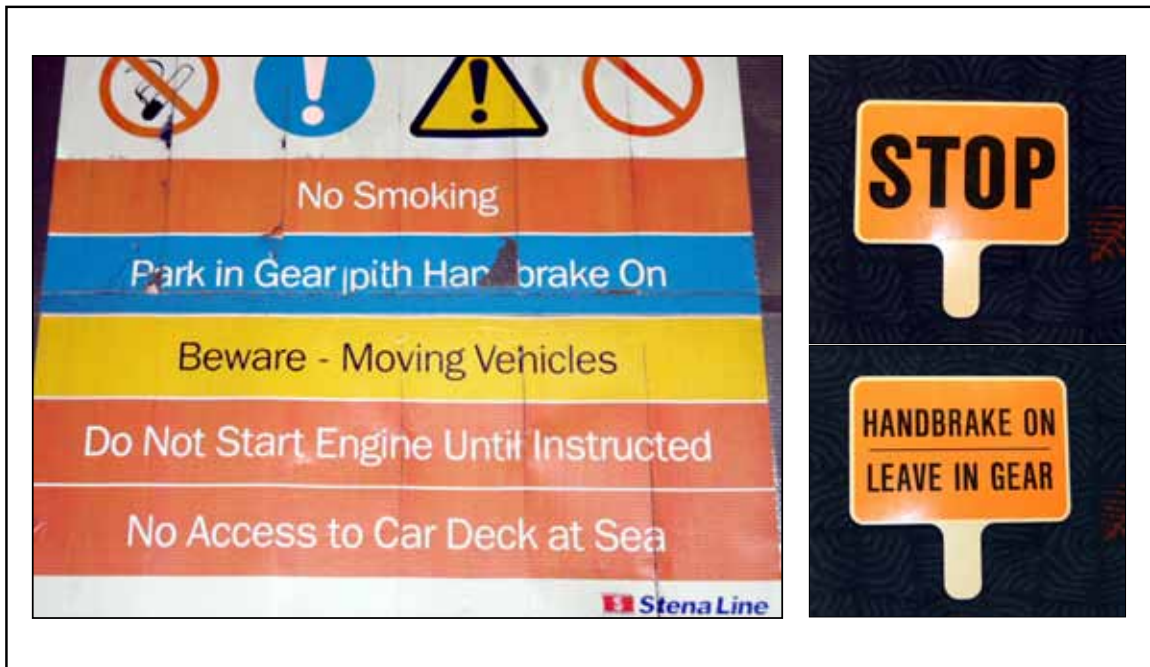
The crew did not verbally instruct drivers to apply parking brakes or seek confirmation that they had done so during the loading operations, but warning posters on the vehicle decks provided a visual prompt for drivers. Hand-held instruction boards were held on board, but were not used (**Figure 13**).

Vehicle deck warning signs and hand-held instruction boards

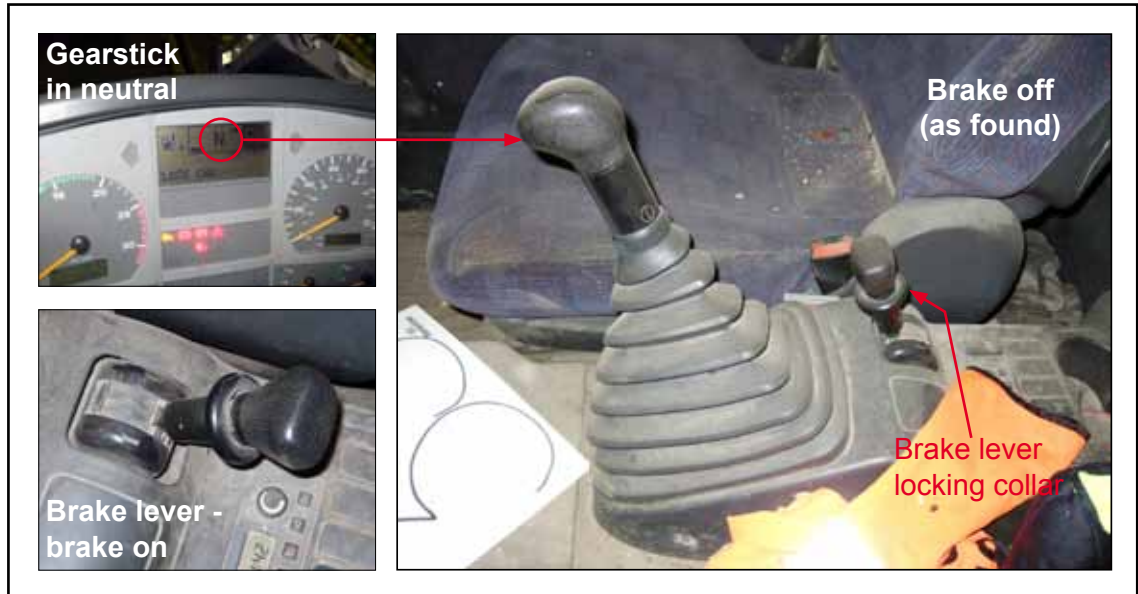
Figure 16

Road tanker tractor unit brake and gearstick

When the road tanker was inspected after the accident its parking brakes were found to be off and its gearstick was in the neutral position (**Figure 16**). The hand brake safety catch mechanism functioned correctly and no faults were found with the braking systems.

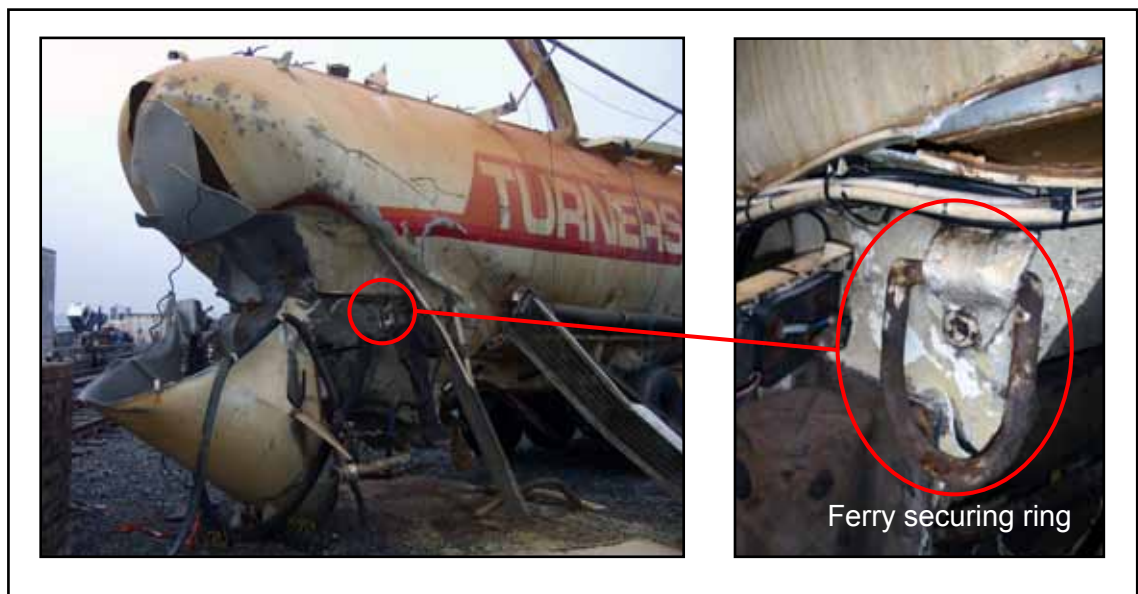
Figure 17

The semi-trailer had two ferry securing rings fitted at its forward end, one on each side (**Figure 17**). The tractor unit had no ferry securing rings. This was the standard configuration on all of Turners' road tankers which were intended to travel by ferry.

Road tanker ferry securing rings

To comply with the guidance provided in IMO resolution A.581(14), the CSS and MCA codes of practice, and the ISO standards, the semi-trailer of the Turner's road tanker should have been fitted with four ferry securing rings on each side. However, it was only fitted with one pair at its forward end. The findings highlighted in paragraph 1.11.1 indicate that the majority of freight vehicles arriving for embarkation on ferries in UK and other European ports do not have the recommended number of ferry securing rings fitted. Moreover, a significant percentage has none at all.

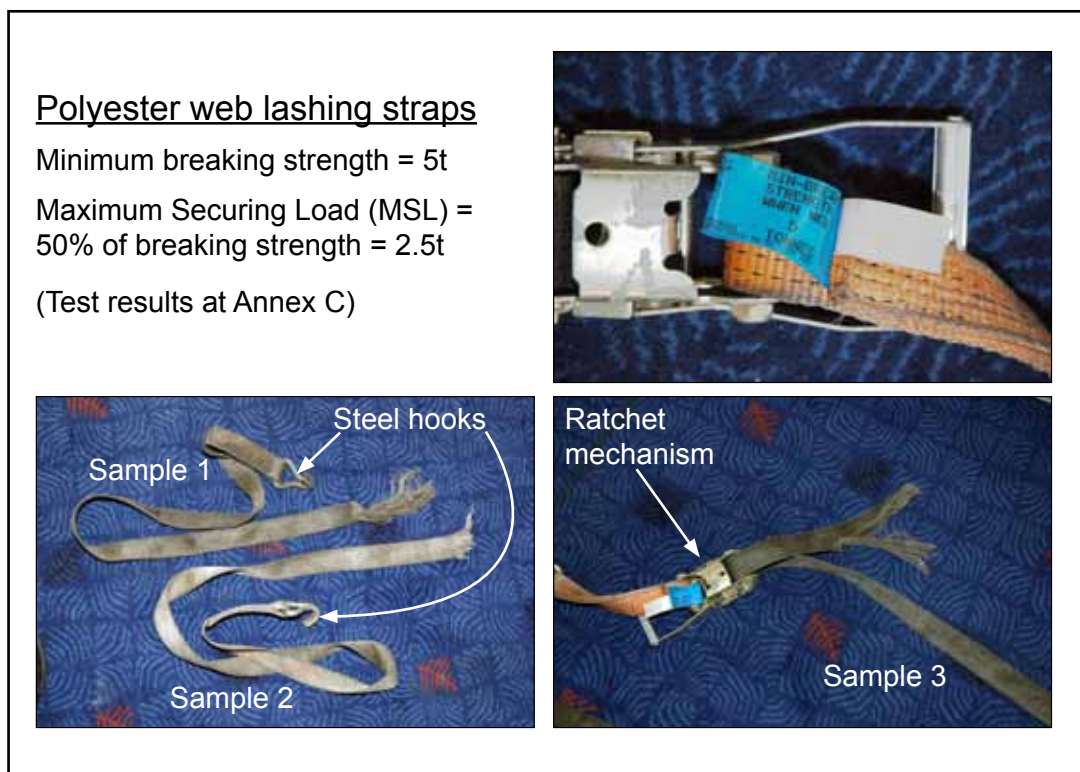
The crew recovered three lengths of failed web lashing after the accident (**Figure 19**). Subsequent analysis (**Annex C**) concluded that two of the failed samples were from the same lashing. One of the lashings had lost 43% of its original strength and the second had lost 65%; the residual breaking strengths were 2.85t and 1.76t. Visually, the lashings appeared as though they had been in service for some time.

Failed lashing straps recovered from the accident scene

Analysis of the failed lashings recovered from the scene of the accident identified that the residual strength of the web lashings used to secure the road tanker was as low as 35% of their design strength. Therefore, the maximum restraining force achievable from the two forward lashings was only 3.5t. Although it was still possible for the lashings to have prevented the vehicle from moving, it would only have required the road tanker to build up momentum over a few centimetres to induce a sufficient shock loading to cause the lashings to fail.

The degree to which the lashings had degraded was attributed mainly to their age, and wear and tear, and was not easily identifiable by visual inspection alone (**Annex C**). Therefore, the need to introduce procedures enabling web lashings to be identified, and to be renewed after being in service for a maximum specified period, is compelling.

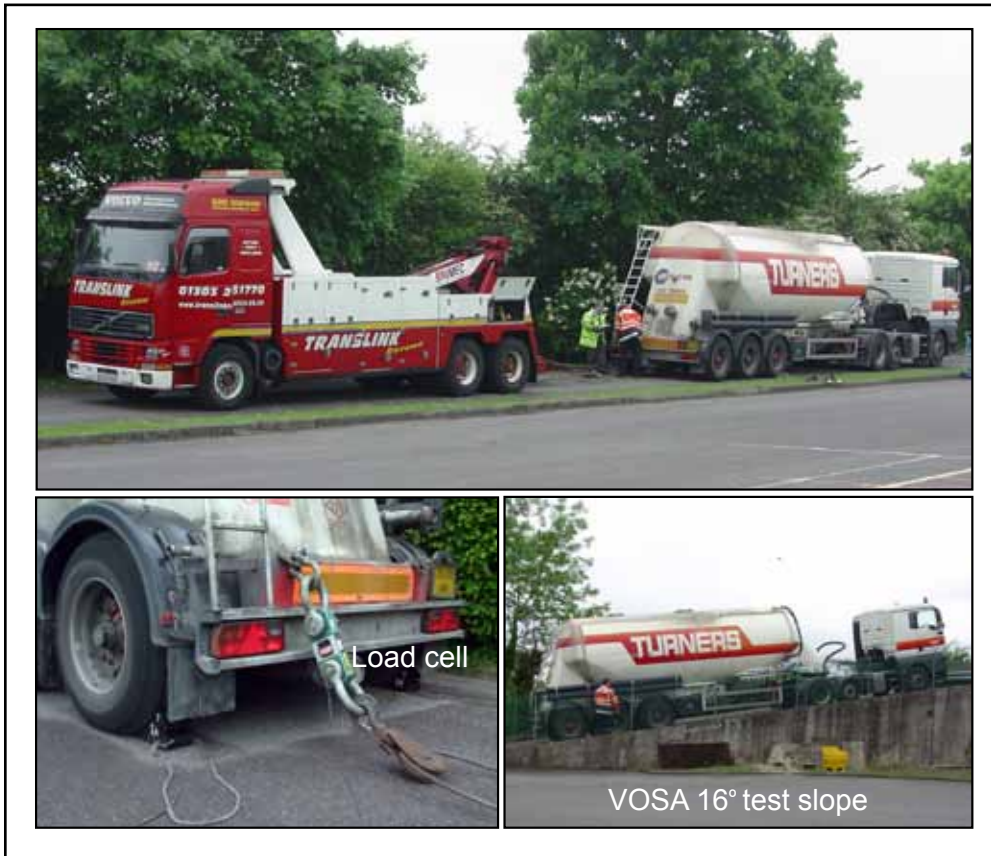
On 13 May 2009, the MAIB, in co-operation with the Vehicle and Operator Services Agency (VOSA) conducted a set of tests to determine the forces required to pull a fully loaded (44t) articulated road tanker, without brakes or lashings, over the three types of rubber chocks most commonly used by Stena Line (**Figure 20**). The results (**Annex D**) found the best performing chock provided an average restraining force equivalent to 4.28t when two were positioned behind the rear wheels of the semi-trailer on level ground; the worst provided a restraining force of 3.5t. The chocking of one wheel effectively halved the restraining forces provided.

Further tests demonstrated that as the gradient of the road was increased, the force required to pull the vehicle over the chocks was reduced. Calculations indicate that the force acting on a 44t road tanker due to its weight alone would cause it to roll over the best performing chock at an angle of 6°. Measurements were also taken on an inclined section of road to establish the magnitude of shock loads applied by a free rolling vehicle to initially slack lashing straps. The maximum theoretical force acting on the road tanker in the aft direction during the trans-critical phase of *Stena Voyager's* passage was calculated to be almost 3t.

Wheel chock performance tests

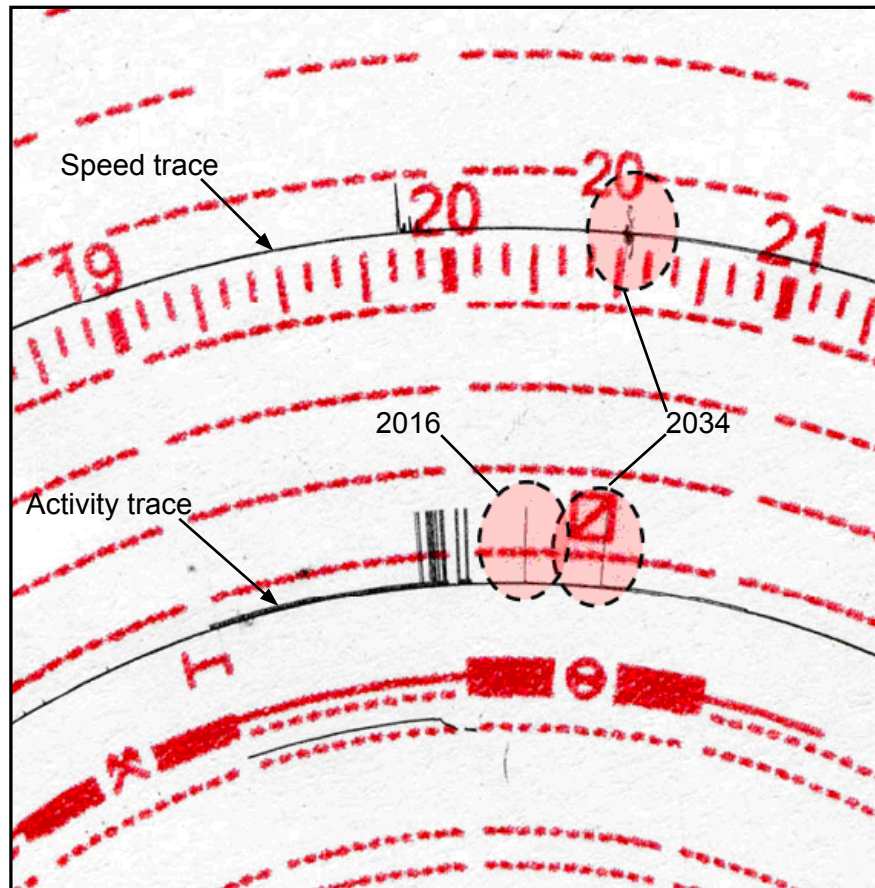
Despite its engine being stopped, the road tanker's movement at the time of the accident was recorded on the disc (**Figure 21**). The violence of the impact on the vehicle as it crashed through the stern door was also sufficient to create marks on the vehicle's speed trace. Careful analysis of the disc indicates the road tanker probably moved aft at 2016, shortly after *Stena Voyager* departed the berth. This was 18 minutes before it passed through the stern door.

Tachograph marks

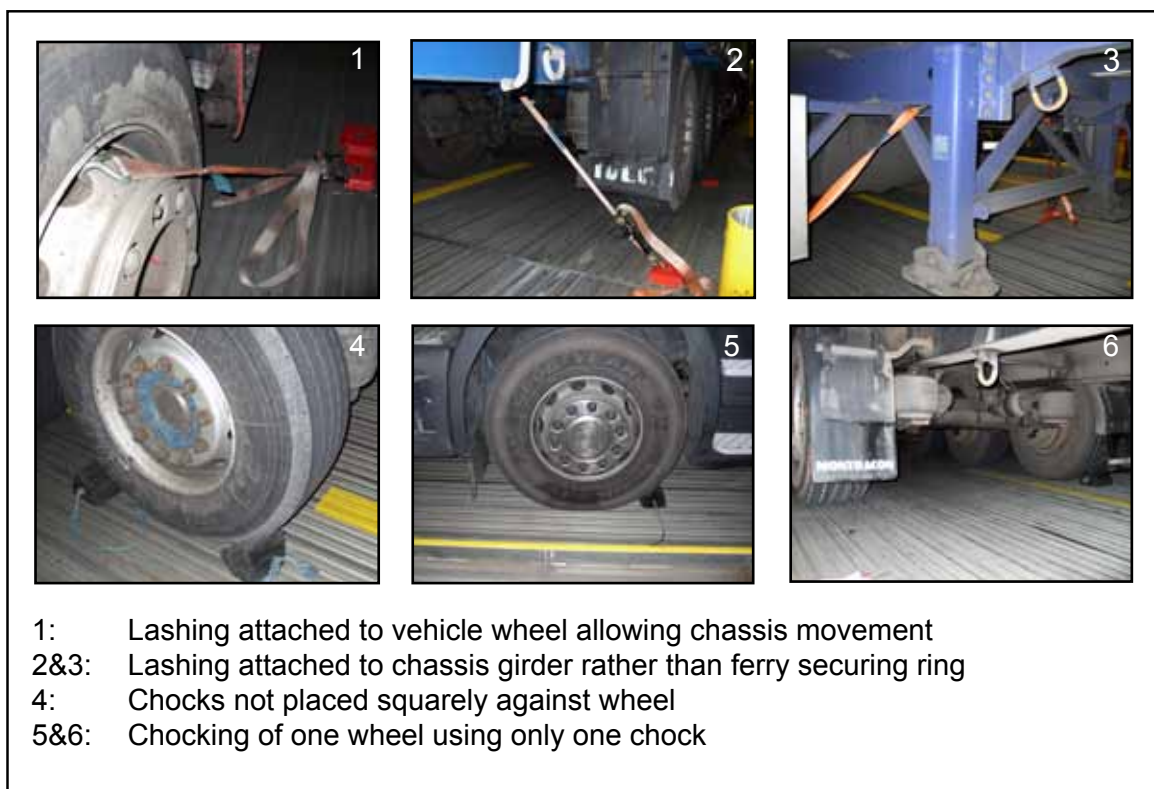
During the visit to *Stena Explorer*, a review of her cargo securing manual found that the cargo securing requirements set out in SMSO number 23 differed from those given in the equivalent document on board *Stena Voyager*, and both contradicted the instructions given in SMSO number 8 (**Annex A**). The crew were observed to chock one wheel on each vehicle, and in some cases chocked only one side of a wheel; not all chocks were placed squarely against the wheels (**Figure 24**). Several vehicles were found to be secured with fewer than four lashings.

The crews of *Stena Voyager* and *Stena Explorer* had adopted different securing practices, and neither was fully compliant with the minimum requirements set out in the cargo securing manuals. This had not been identified by any internal or external audits.

Securing practices on board *Stena Explorer*
