Report on the investigation of  
the collapse of cargo containers on

***Annabella***

26 February 2007

**Report No 21/2007**  
**September 2007**

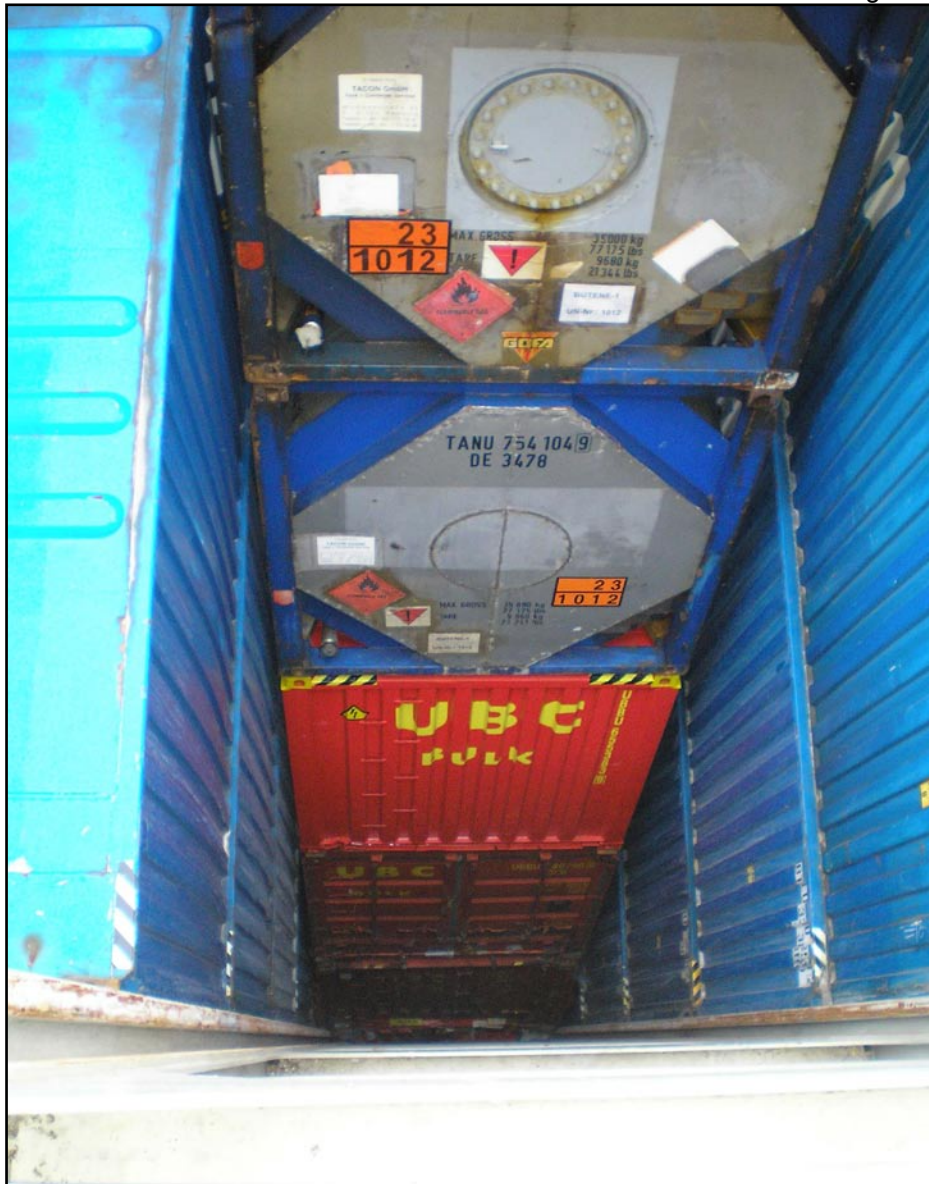
At 0830 the chief officer was undertaking routine rounds of the cargo when he discovered that seven 30 foot containers had collapsed in the centre of bay 12, number 3 hold and were lying at an angle against the forward end of the hold (**Figure 3**). He observed that bulk cargo had spilled from the lower containers, the bottom two of which had been crushed. The upper three containers in the collapsed stack were all tank containers full of Butylene Gas (IMDG Class 2.1, UN 1012) and appeared to have suffered some damage.

Looking down on the aft end of the collapsed stack of containers

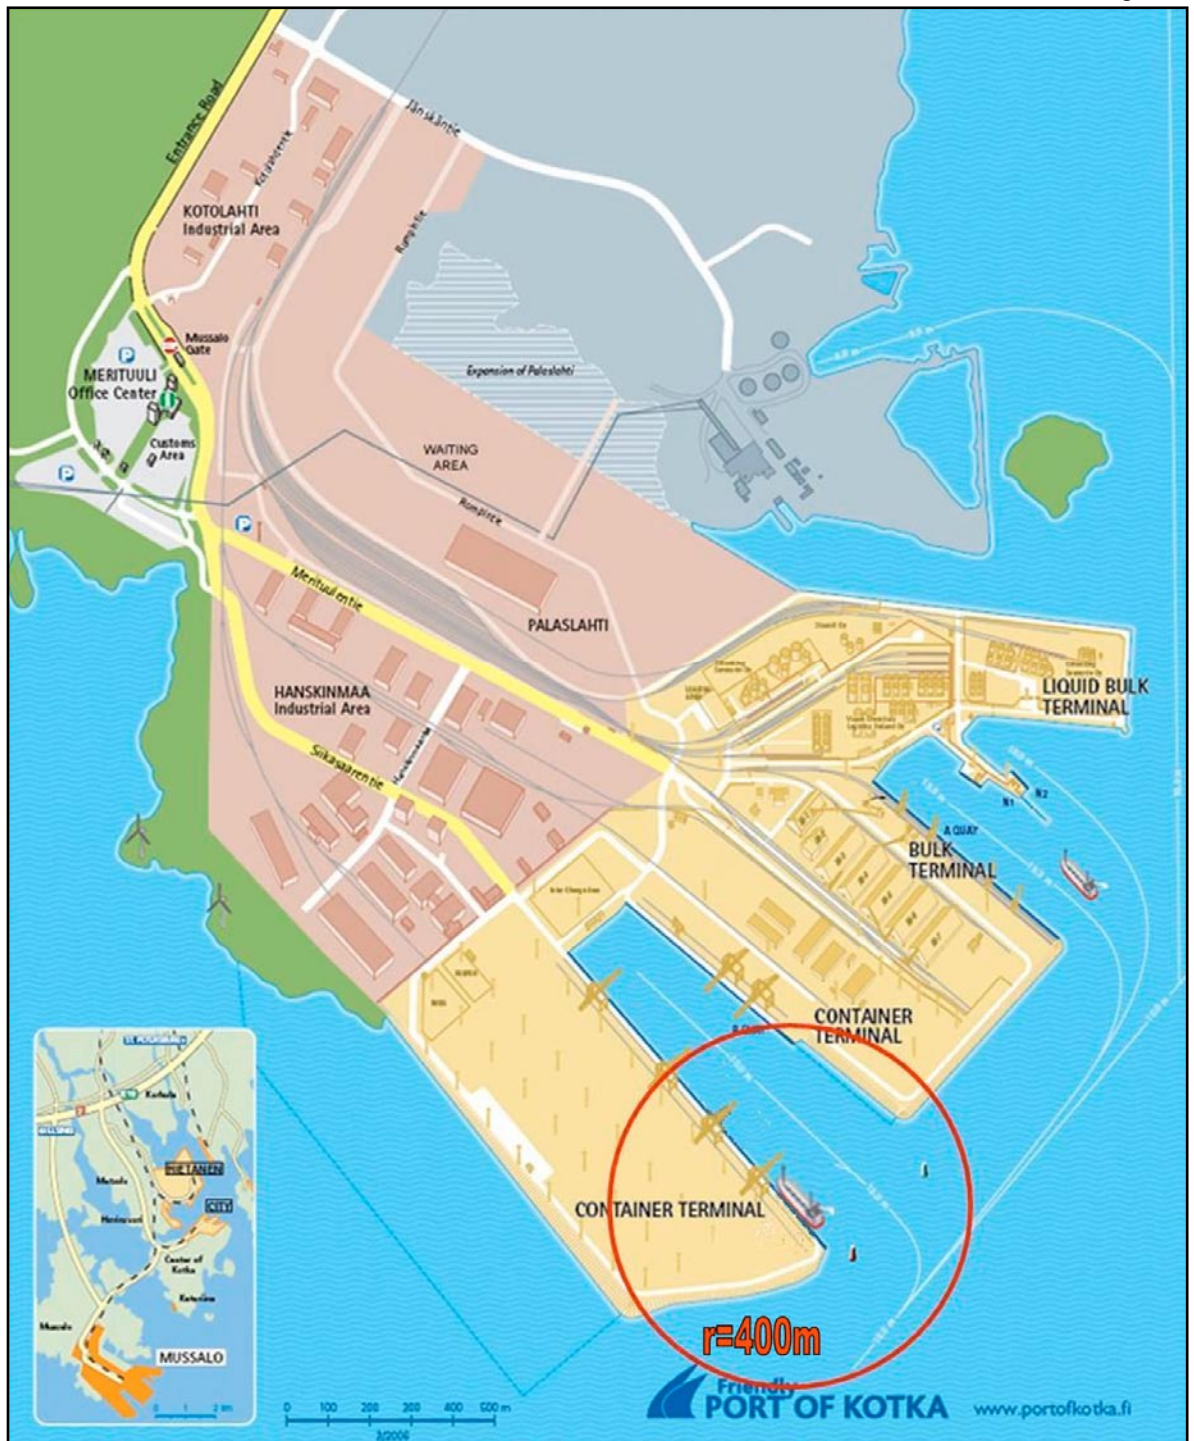
Figure 4

At 1542 on 27 February, with the assistance of an icebreaker, the vessel berthed at the Mussalo container terminal, where a 400 metre restricted area was established around her (**Figure 4**). The local authorities and vessel's representatives then began to develop a plan for the safe discharge of the damaged containers.

400 metre restricted area placed around vessel at Kotka - Finnish emergency plan

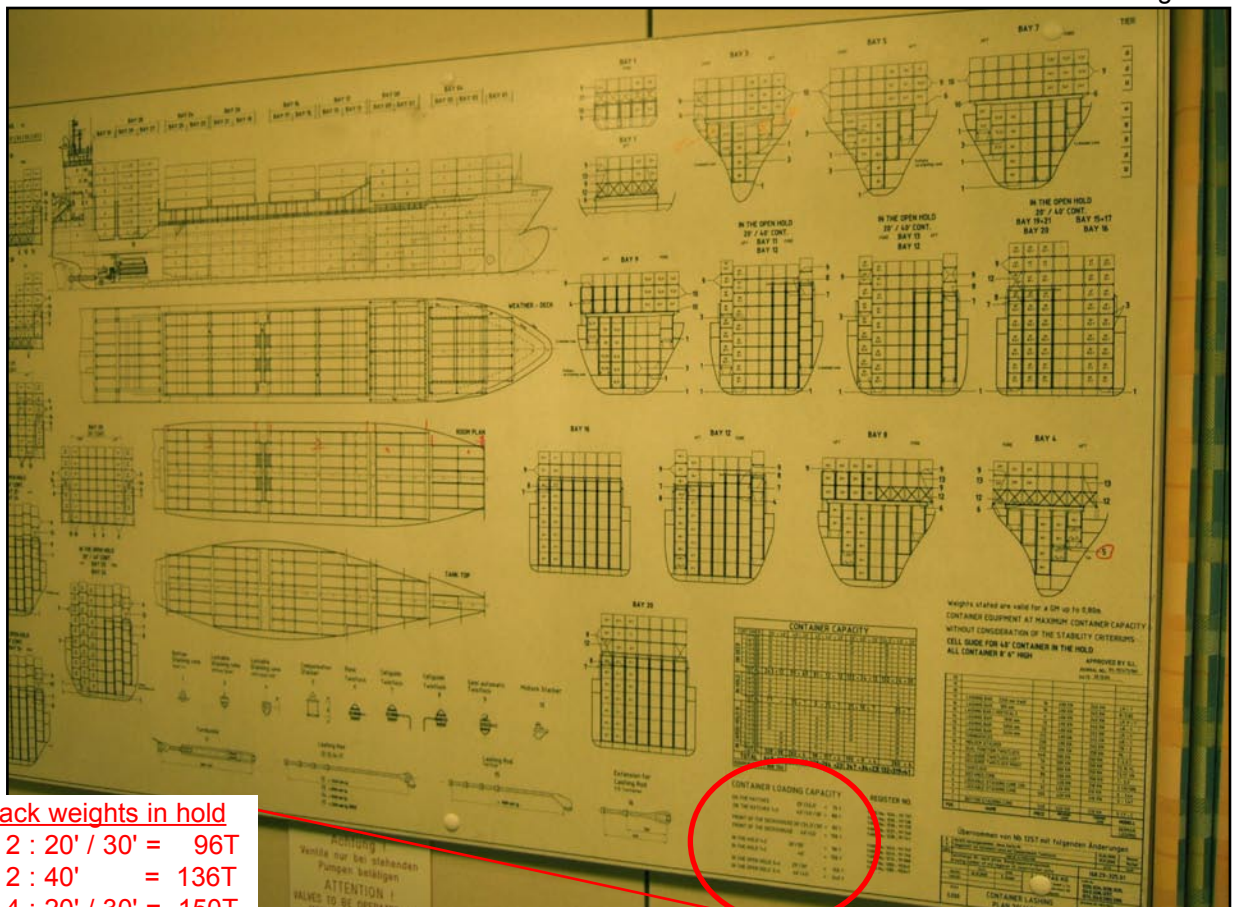
Figure 7

The Container Lashing Plan (**Figure 7**), another annex to the cargo securing manual, had been approved by GL on 30 December 2004 and was permanently displayed on a bulkhead in *Annabella's* cargo office. This plan indicated the lashings required on

Max' stack weights in hold  
 Hold 1 + 2 : 20' / 30' = 96T  
 Hold 1 + 2 : 40' = 136T  
 Hold 3 + 4 : 20' / 30' = 150T  
 Hold 3 + 4 : 40' = 240T  
 (based on GM of 0.8m)

Container lashing plan

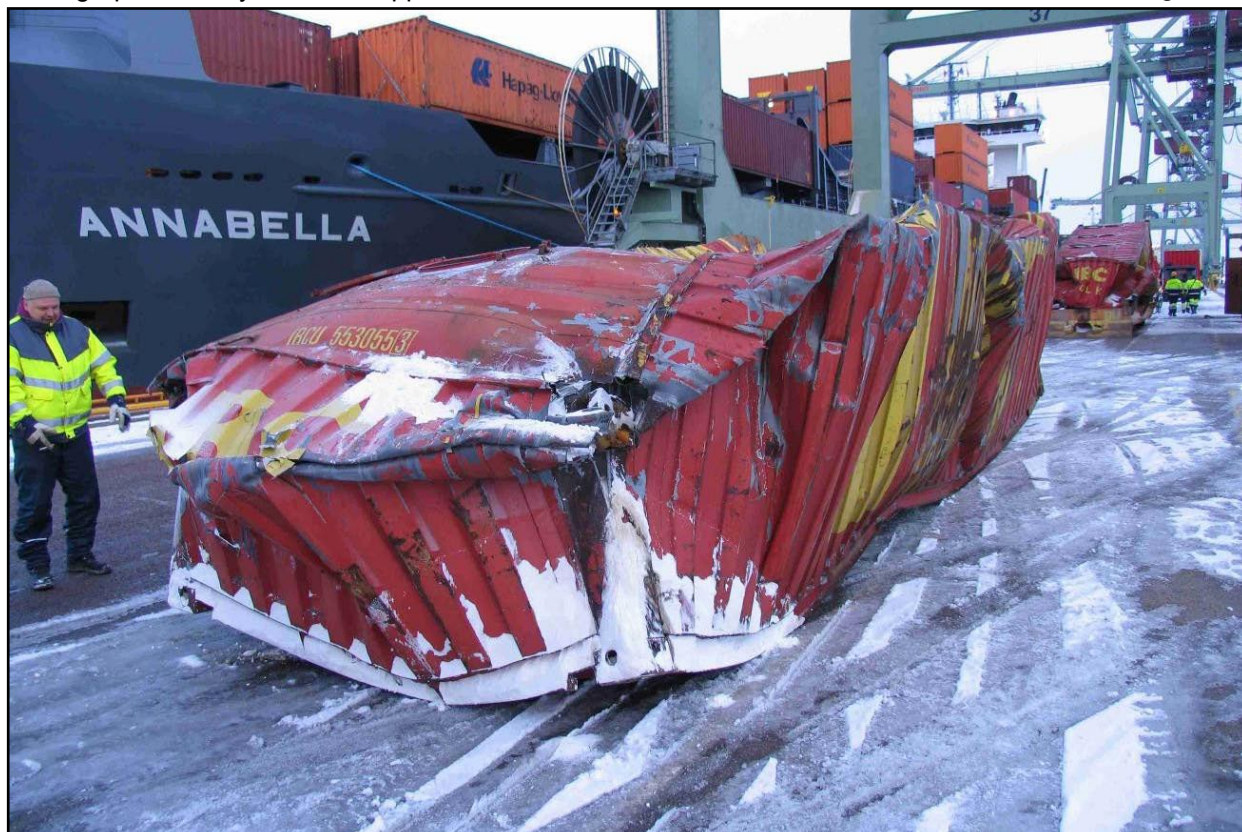
Figure 10

When the bulk containers from the collapsed stack were being discharged in Kotka on 5 March 2007, it was confirmed that the two containers at the bottom of the stack had been crushed during the voyage (**Figure 10**).

Lowest container discharged at Kotka, 5 March 2007

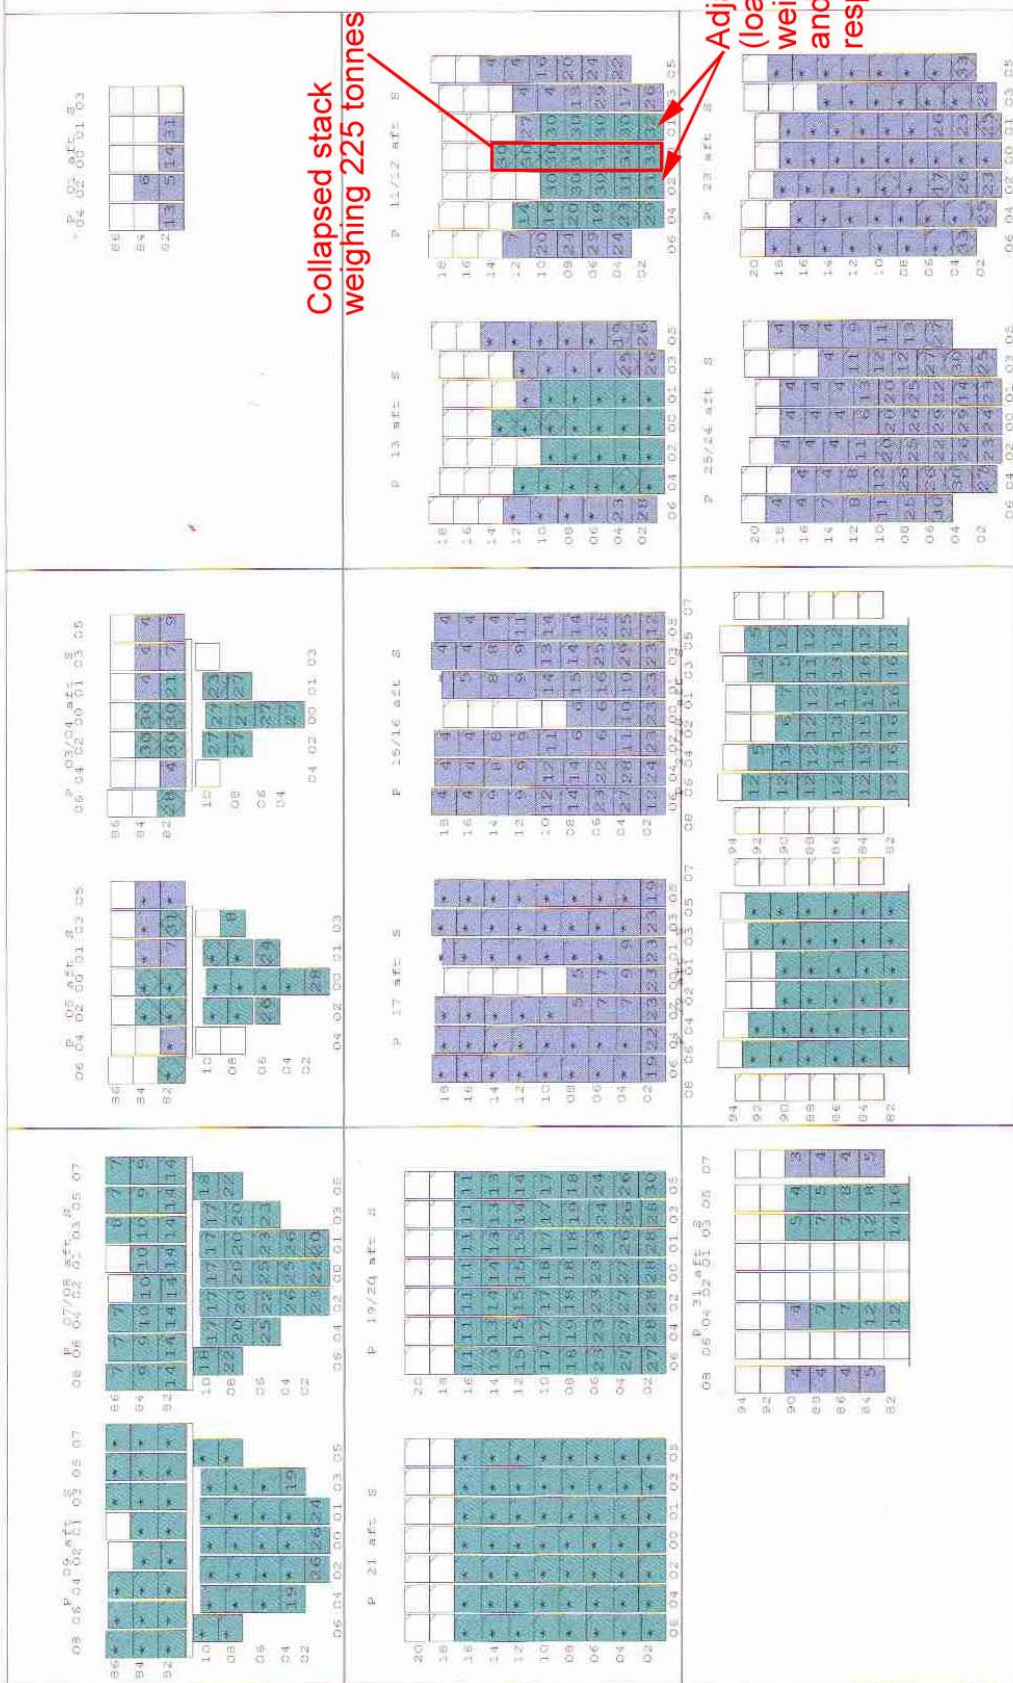
On 23 February, 2 stacks of 30 foot containers were loaded in Antwerp, and were stowed either side of the collapsed stack in number 3 hold. The stack weights were respectively 152 and 179 tonnes (**Figure 11**). Apart from minor impact damage on the sides of some of these containers, from contact with the collapsed stack, these containers remained intact in their stacks.

Cross section of container stowage plan

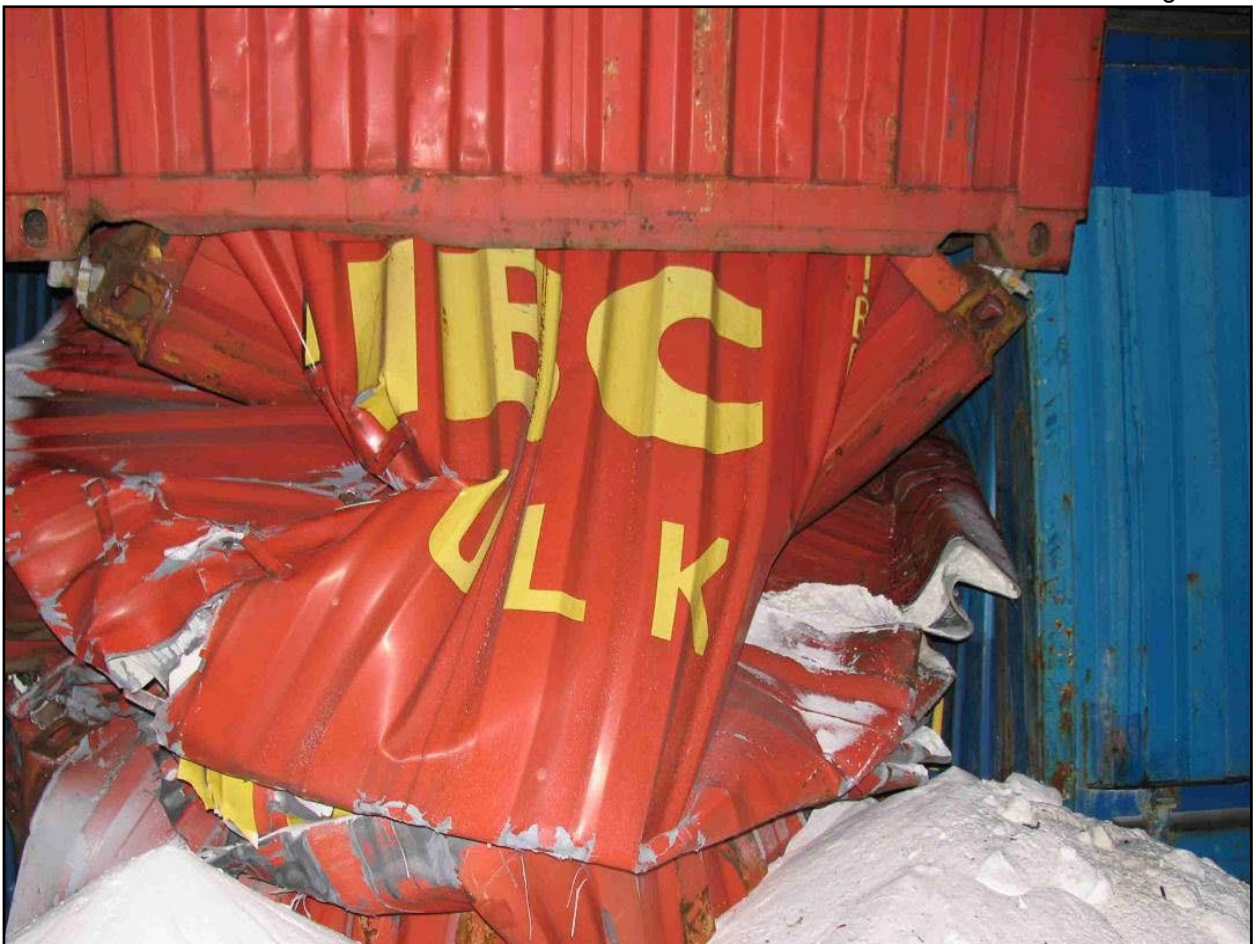
Figure 13

The two containers stowed at the bottom of the collapsed stack of seven containers were crushed by the weight of the containers loaded above them (**Figure 13**). The containers were of similar construction, and both had an allowable stacking weight for 1.8g of 100.5 tonnes.

Crushed containers

As a result of the stowage, the weight of the stack of containers placed on the lowest container was 191.22 tonnes and the weight above the second lowest was 159.14 tonnes.
