Ankring

**Linnéuniversitetet**
Sjöfartshögskolan

P-Å Kvik

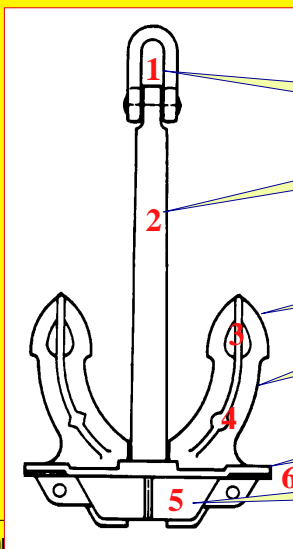
Ankarets delar

1 Anchor ring (Röring)

2 Shank (Lägg)

3 Pea or Bill (Fly/pynt)

4 Fluke (Arm)

5 Tripping palm (Hjälpfly)

6 Crown (Krona)

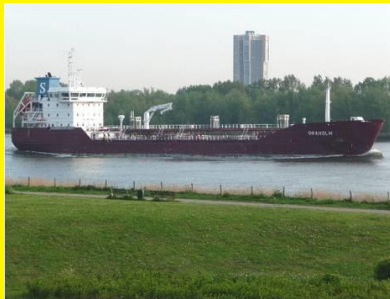
Lost anchor

- **4,600-dwt Danish tank M/V Orahholm lost both anchors and anchor chains in stormy weather in the North Sea on its way from Gdansk to Rouen on Oct 27. It is unclear whether the salvage company will recover the lost anchor gear. [28-10-10]**

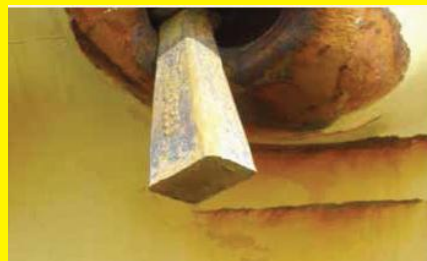
Lost Anchor ?

- **The starboard anchor was weighed and the vessel proceeded to berth. The starboard anchor was again used during berthing along with the mooring lines as per the port procedures, and six shackles were deployed in 25 metres of water. The next day, after discharging a parcel of cargo, the vessel was departing the port; the anchor was to be weighed after letting go the lines. As the starboard anchor broke the surface of the water the officer on duty informed the wheelhouse that the flukes and crown of the anchor were missing.**

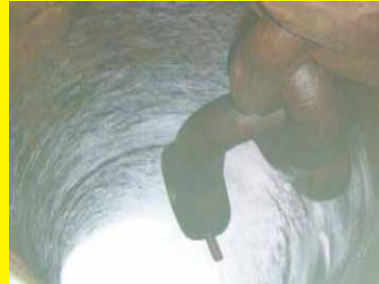
Lost anchor in bad weather

- A few hours after leaving port the weather conditions deteriorated and the Master reduced speed, taking all necessary precautions for navigation in bad weather. Some time later the weather improved and the Master had the crew check the forecastle for any damage and the lashing and anchor stowage. All was found in order. The same day, the chief officer went forward on safety rounds and both anchors were once again found in the proper stowage position and secured. Later that day the weather turned bad again until the late morning of the next day. At that time the starboard side anchor was found missing while the chain, including the swivel and the end link, was still onboard.

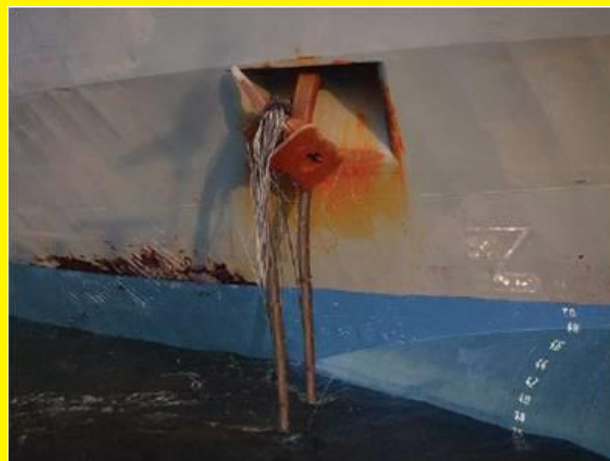
Vessel's anchor, fouled with a power cable

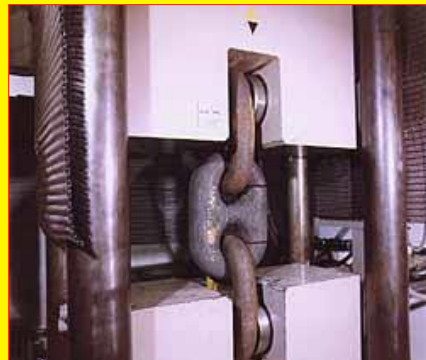
ANCHORING Equipment Number

- The Equipment Number will determine
 - # of anchors
 - Weight of anchor
 - Chain length
 - Diameter of chain
 - Breaking load

$$EN = \Delta^{2/3} + 2BH + 0,1A$$

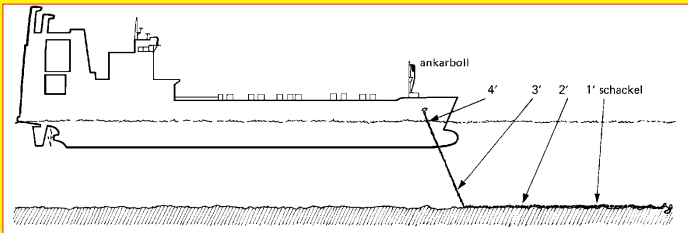
Length of chain

- **Factors to consider when determining length of chain**
 - Depth of water
 - Time at anchor
 - Bottom
 - Exposure- shelter
 - Current - tide
 - Weather, vind
 - Ice

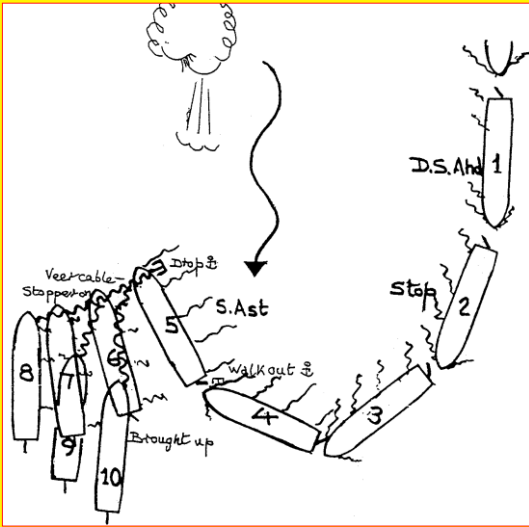
ANCHORING MANOEUVRES

Diagram illustrating anchoring manoeuvres. The ship's path is shown with numbered steps (1-10) and labels: D.S. Ahl 1, Stop 2, S. Ast, Walkout 3, Brought up, 4, 5, 6, 7, 8, 9, 10. The diagram also shows the ship's position relative to the anchor and the anchor's position relative to the ship.

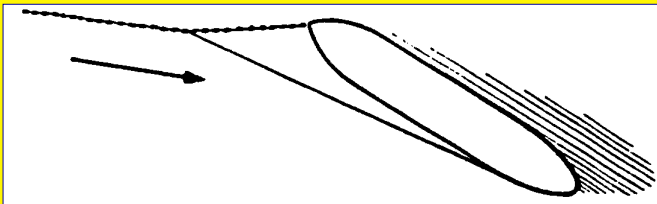
ANCHORING MANOEUVRES

Diagram illustrating anchoring manoeuvres. The ship's path is shown with numbered steps (1-10) and labels: D.S. Ahl 1, Stop 2, S. Ast, Walkout 3, Brought up, 4, 5, 6, 7, 8, 9, 10. The diagram also shows the ship's position relative to the anchor and the anchor's position relative to the ship.

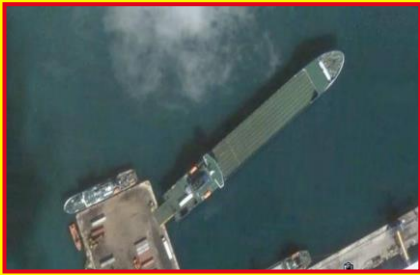
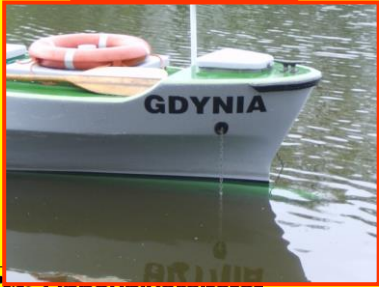
Mediterranean mooring Simulator and manned model

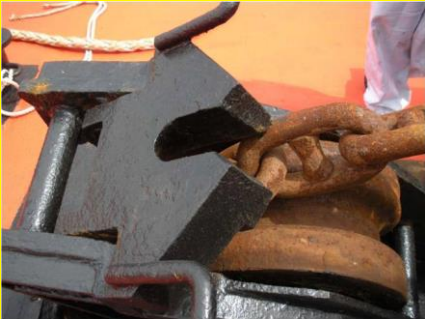
Chain stopper pawl type

- The pawl does not fit the chain and will not lock the chain from being pulled out.
- When at anchor, this vessel will depend on windlass brake alone.
- The pawl is designed for 80 % of breaking strength of chain, the brake band only for 45 %.

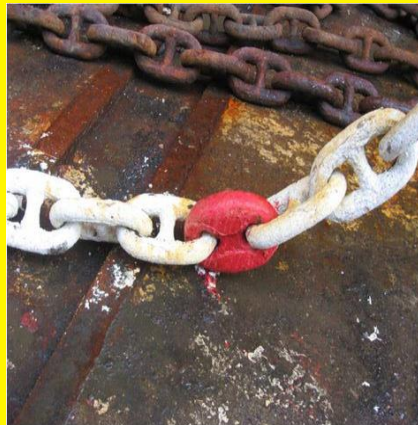
Marking of chain lengths of 15 fathoms(27,5m)

- Kenter shackles are marked red.
- Stud links next to kenter shackles are painted white.
- 3 white links on either side for the third length of chain, 4 for the fourth and so on. Studs may also be marked by thin wire.
- Need to know how much chain is out.
- Some vessels have cable indicators.

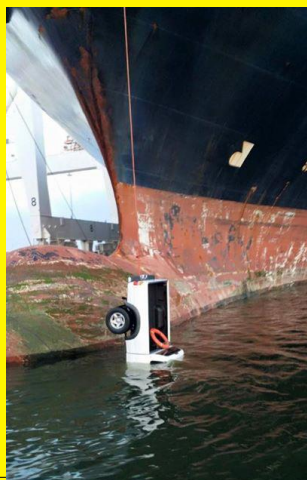
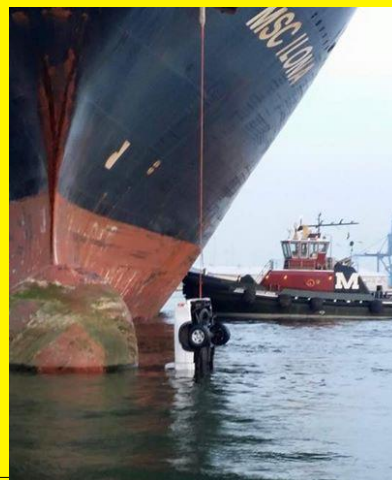
Don't make fast on truck
