Report on the investigation into the grounding,
and subsequent loss, of the ro-ro cargo vessel

Riverdance

Shell Flats – Cleveleys Beach, Lancashire

**Report No 18/2009
September 2009**

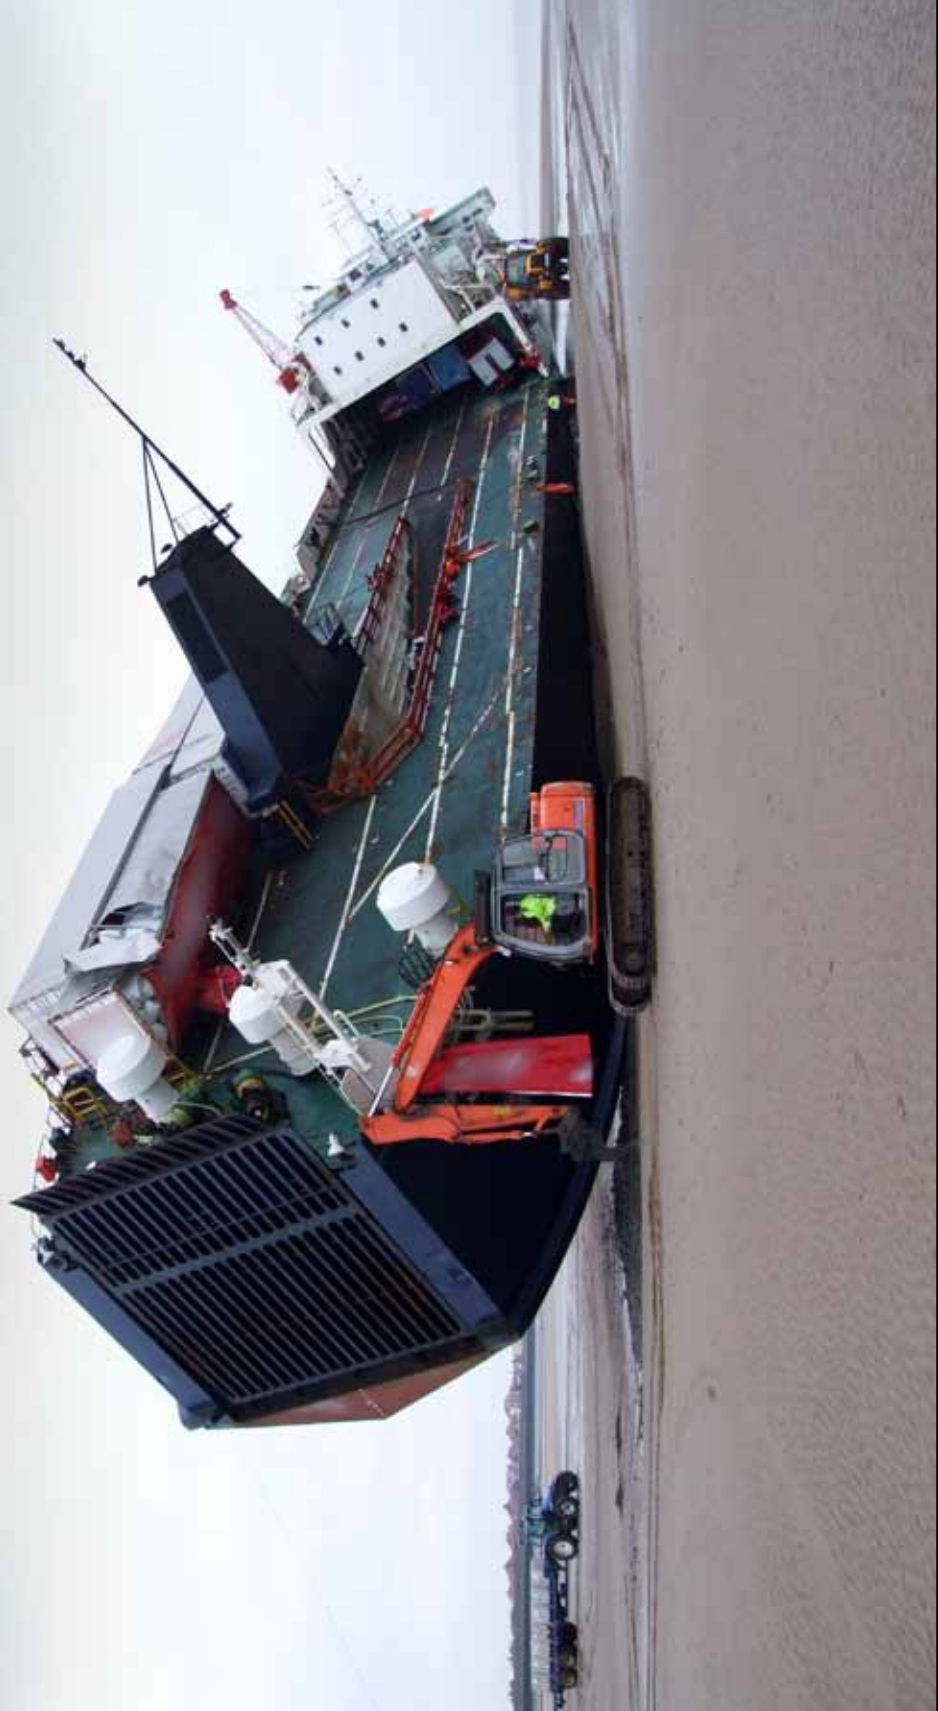
Riverdance aground

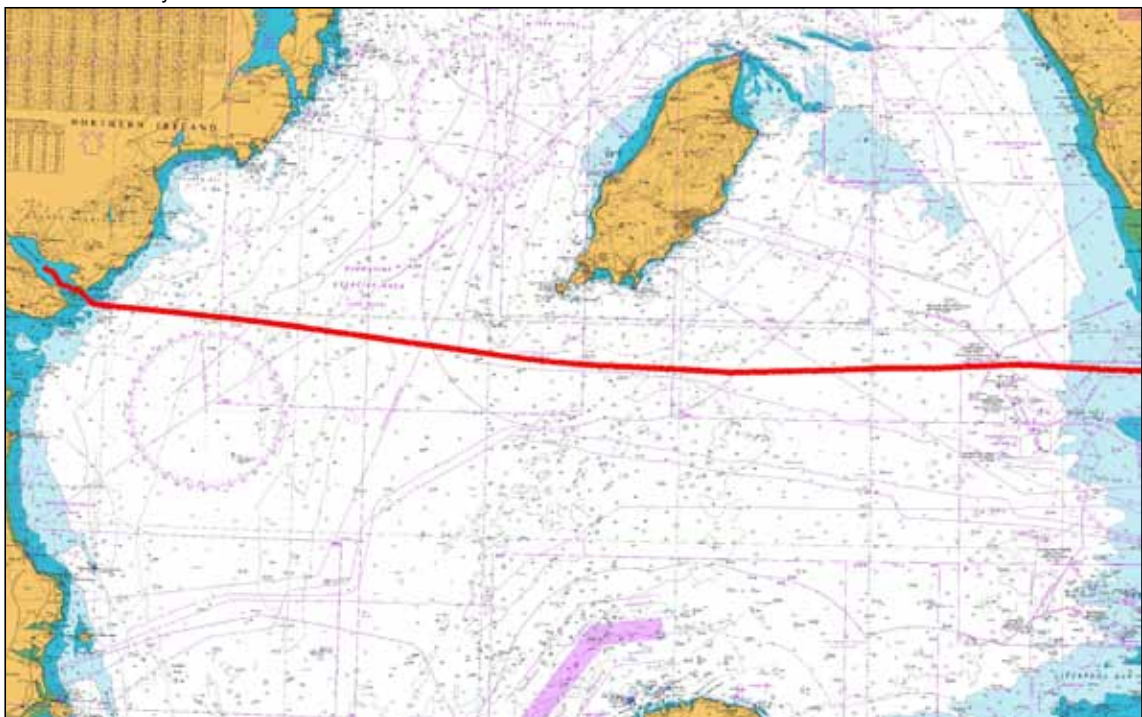
Figure 2

Once safely clear of the berth, *Riverdance* proceeded seaward out of Carlingford Lough. On clearing the Hellyhunter buoy the autopilot was engaged, and a course of 096° was set, directly to the entrance of the Lune Deep (**Figure 2**). By the time *Riverdance* departed Warrenpoint at 1136 she was more than 5 hours behind schedule, mainly due to the late arrival from Heysham. The wind was from the west-south-west between force 7 and 8.

AIS track of the voyage from Warrenpoint to Heysham

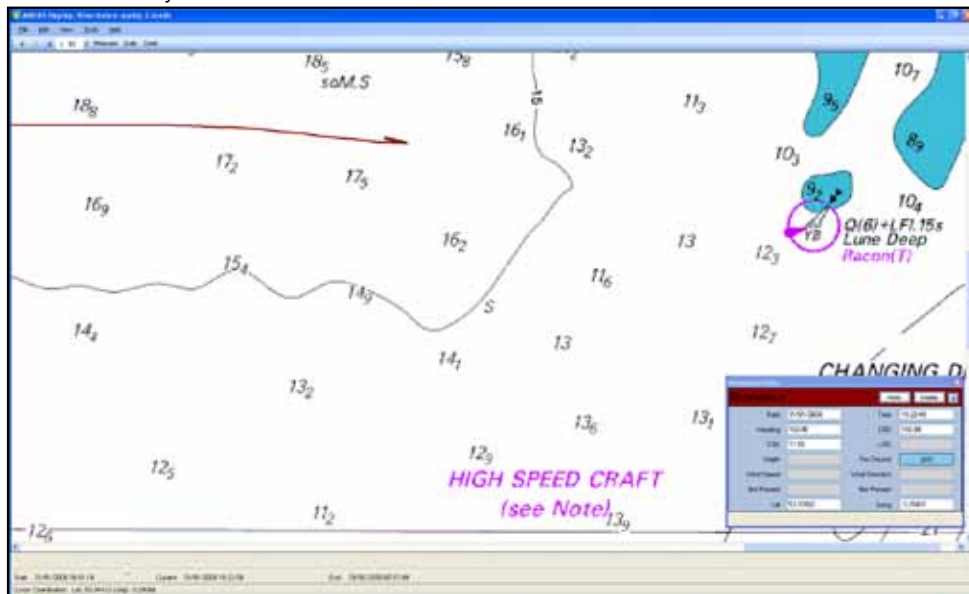
Figure 4a

Riverdance AIS track prior to the turn (Time: 19:22:49)

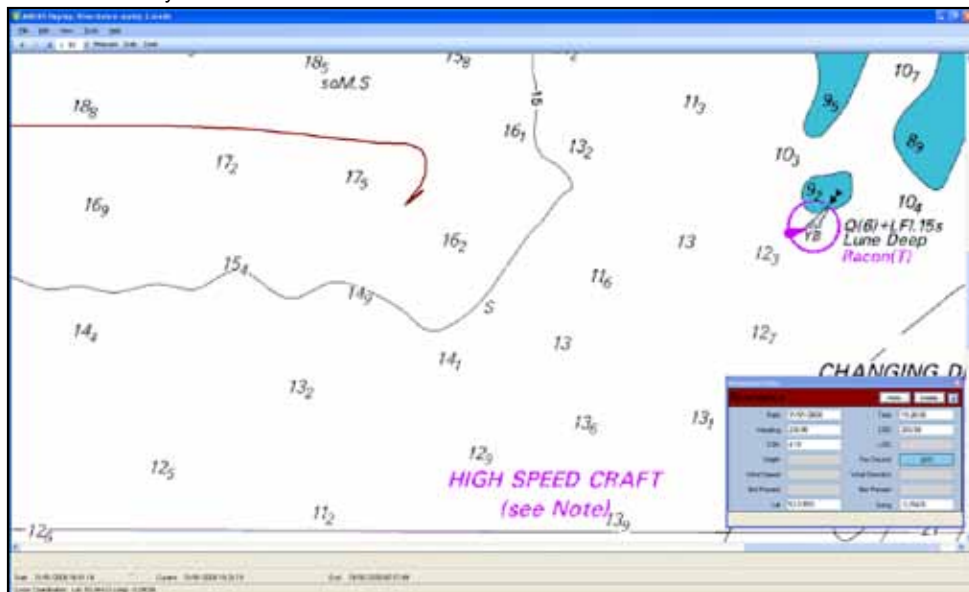
Figure 4b

Meanwhile, on the bridge, the master had disengaged the automatic pilot and, in manual steering, placed the wheel hard over to starboard. It was his intention to bring *Riverdance's* head round into the wind to reduce the rolling. *Riverdance* then experienced a change of ship's head from 103° to 170° within 39 seconds, a rate of turn of over 100° per minute (**Figures 4a and b**). During the turn, the vessel's list to port increased substantially, reportedly up to 50°.

Riverdance AIS track after the turn to starboard (Time: 19:26:09)

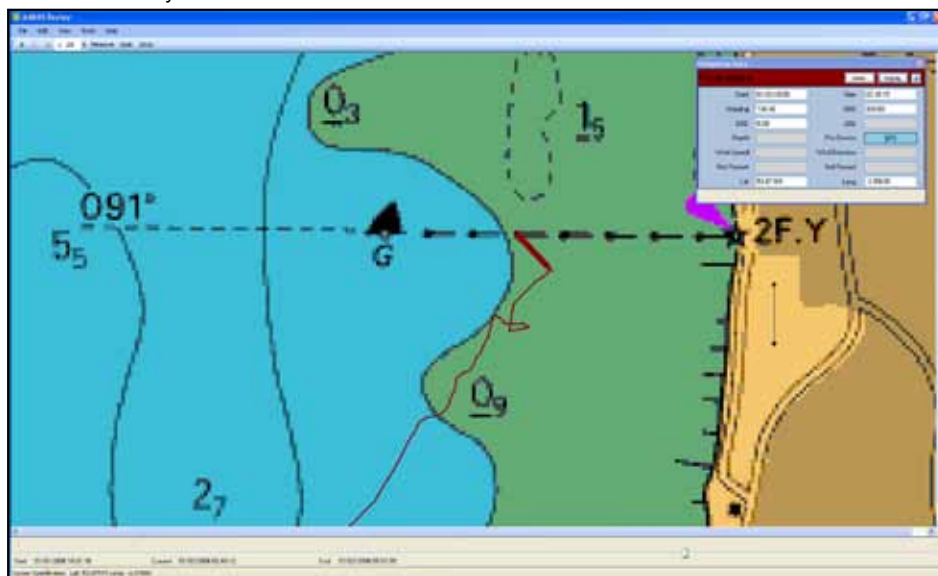
Figure 8

Initial attempts were made to manoeuvre *Riverdance* off the beach just after 0135 when the port main engine was started, and a combination of ahead and astern engine movements, in conjunction with substantial use of the bow thruster was used. The starboard main engine was started at 0203 and the master informed Liverpool coastguard that both engines were running astern. At 0217 *Riverdance* started to move slowly to the north-east, but then stopped with her stern close to a sewer outfall pipe. Soon after this, she swung parallel to the shore line (**Figure 8**).

Position of *Riverdance* at 0239

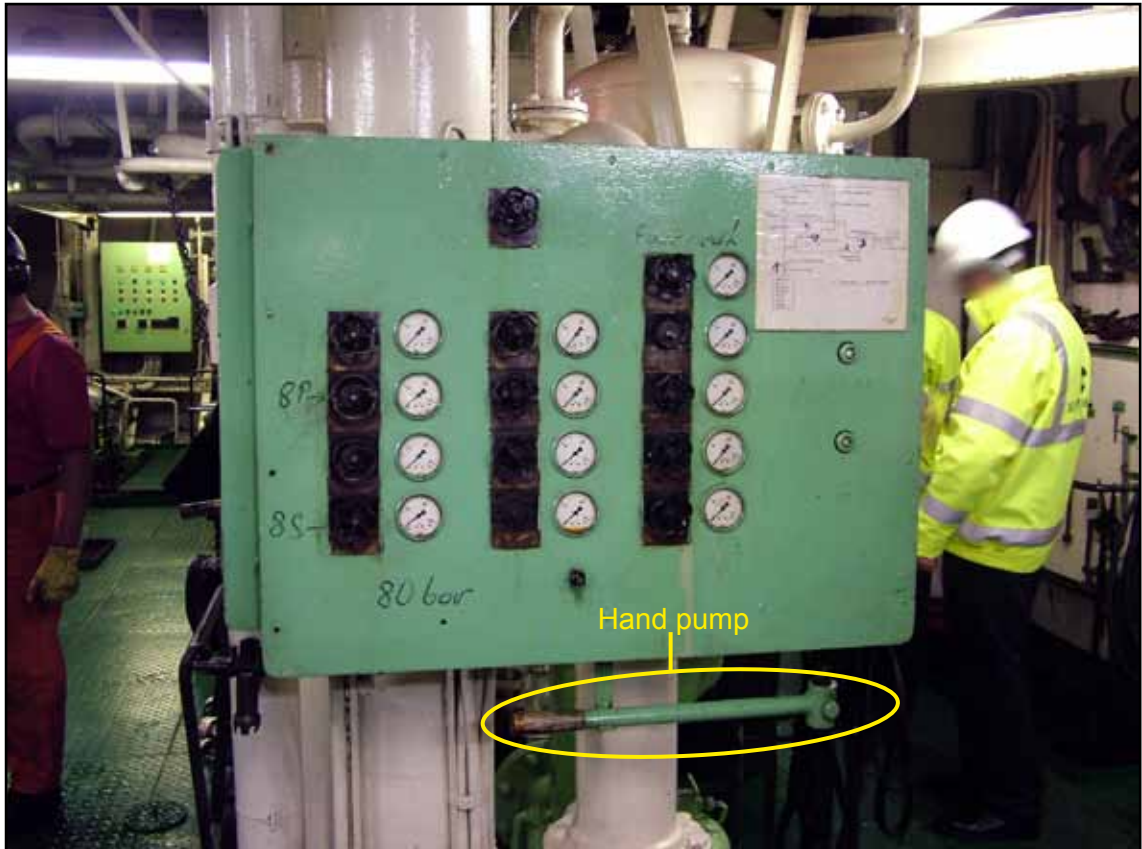
Figure 12b

Riverdance was still fitted with the original ballast valve operating system as installed at new build in 1977. This included a hydraulic storage tank which held about 30 litres of oil (**Figure 12a**). Oil was routed to the required tank ballast valve through a combination of control valves (**Figure 12b**); each individual tank valve consisted of the valve body and an actuator which incorporated a spring-loaded plate. The system provided no mimics at the control station to indicate the states of the valves. The only indication that the valve was fully open was when the in-line pressure gauge indicated a rising pressure and it became difficult to continue pumping as the valve actuator became hard up against its open "stop".

Ballast distribution control panel

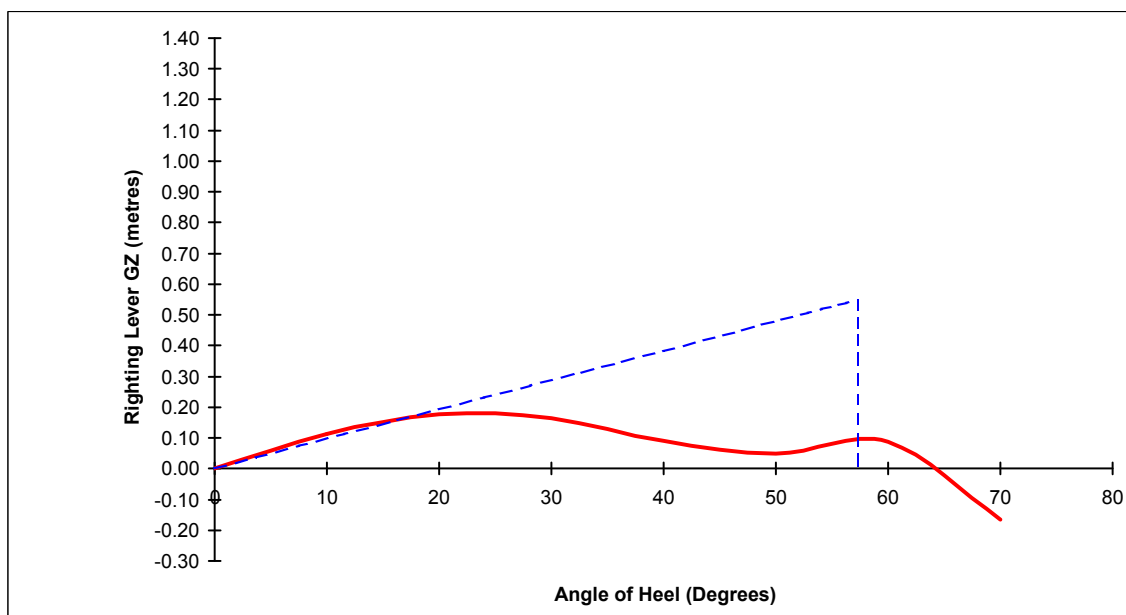
Figure 20b

Copies of *Riverdance*’s WCS were lost with the vessel. Consequently, the document used on *Moondance* was referred to during this investigation (**Annex 9**). The conditions were largely similar for both vessels because they were created on board from the same basic information. From examination of the WCS calculation spreadsheet, using *Riverdance*’s 2000 “approved” hydrostatic and lightship data, the actual values for stability criteria were found to be non-compliant with the 1968 Load Line regulations in a number of areas (**Figure 20a and b**).

GZ curve for the *Moondance* WCS using *Riverdance*'s approved trim and stability data

The difference between the WCS calculated GM of 0.73 m (**Annex 9**) and the calculation as above, of 0.547, was found to be due to errors within the WCS spreadsheet cells, where formulae had been replaced by manual entries. This meant that the weights and moments for stores and crew were not added to the summary of totals. The WCS calculation was also based on an old value for lightweight that had been extant before modification of the vessel.

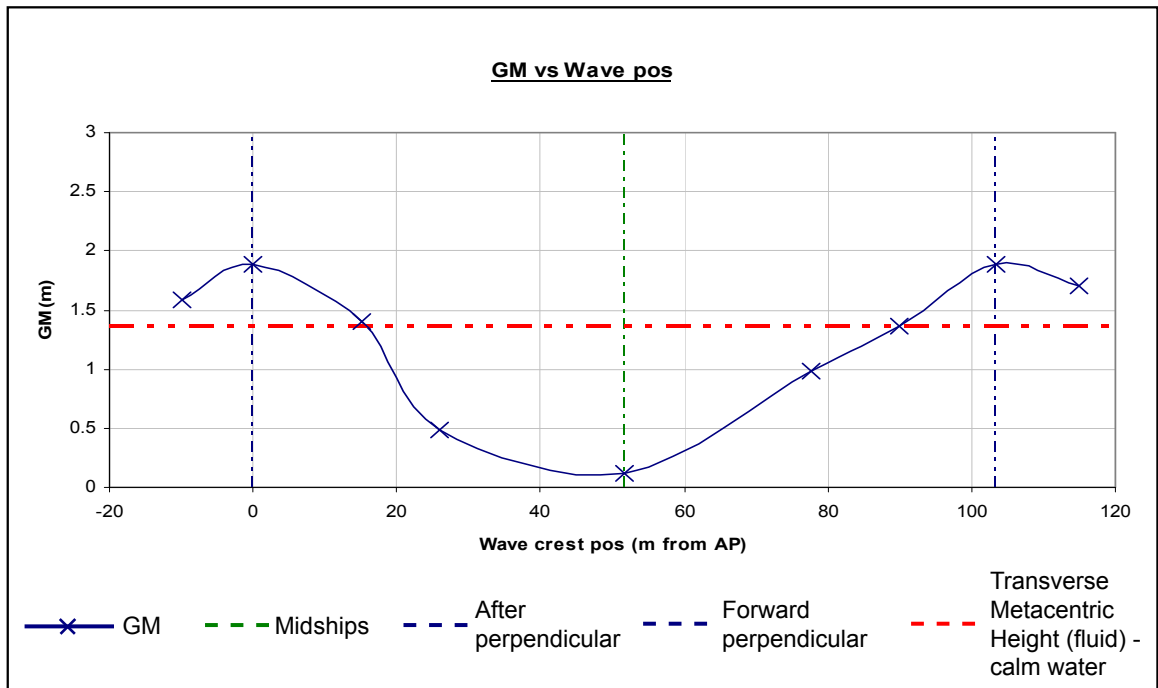
Figure 26

As can be seen in **Figure 26**, in the case of *Riverdance* there would have been a very large reduction in the GM as the wave passed amidships.

Loss of GM on a wave crest (extract from Annex 1 - QinetiQ report, Section 3.2.11)

Based on the departure stability condition of *Riverdance*, it was calculated that the GM could be reduced to 0.10 m or even less, during the passage of the waves.
