Report on the investigation of
the shift of an articulated road tanker on board the
roll-on roll-off high-speed sea service cargo ferry

Stena Voyager

in Loch Ryan

Report No 21/2009
October 2009

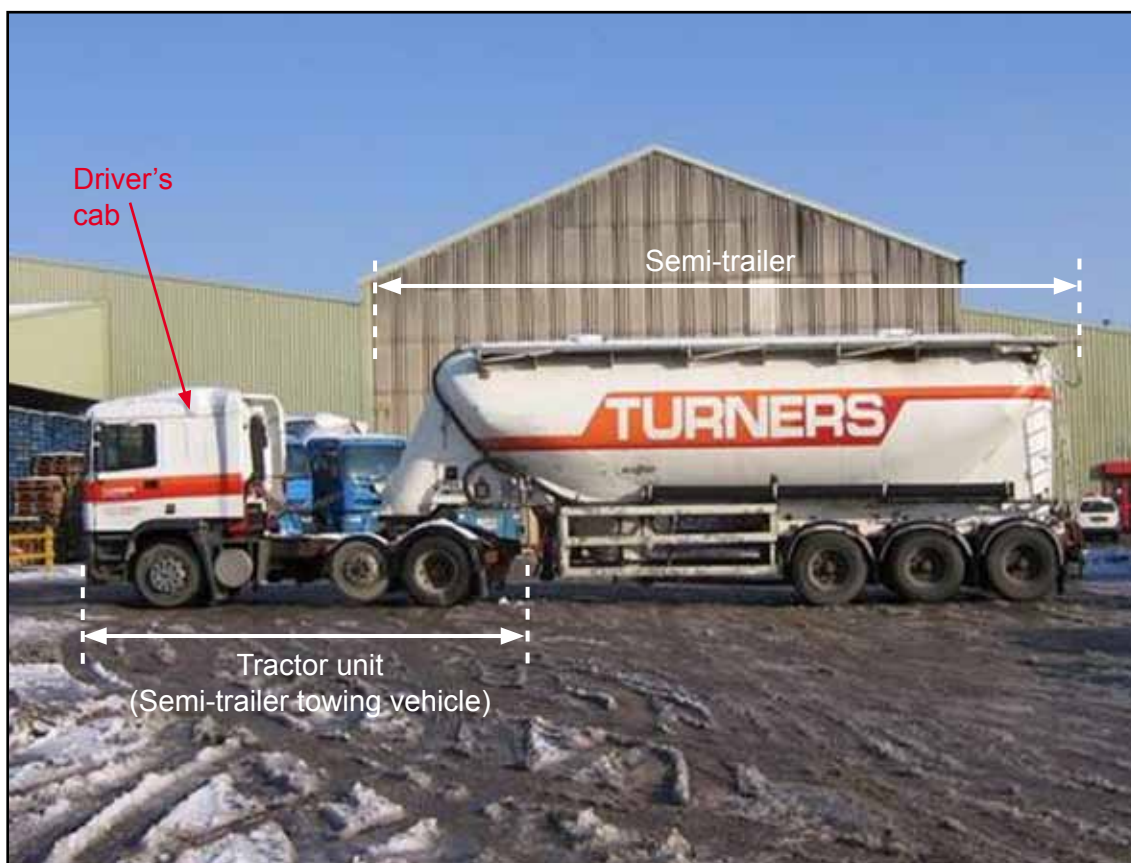
Figure 1

Turners (Soham) Ltd bulk powder articulated road tanker

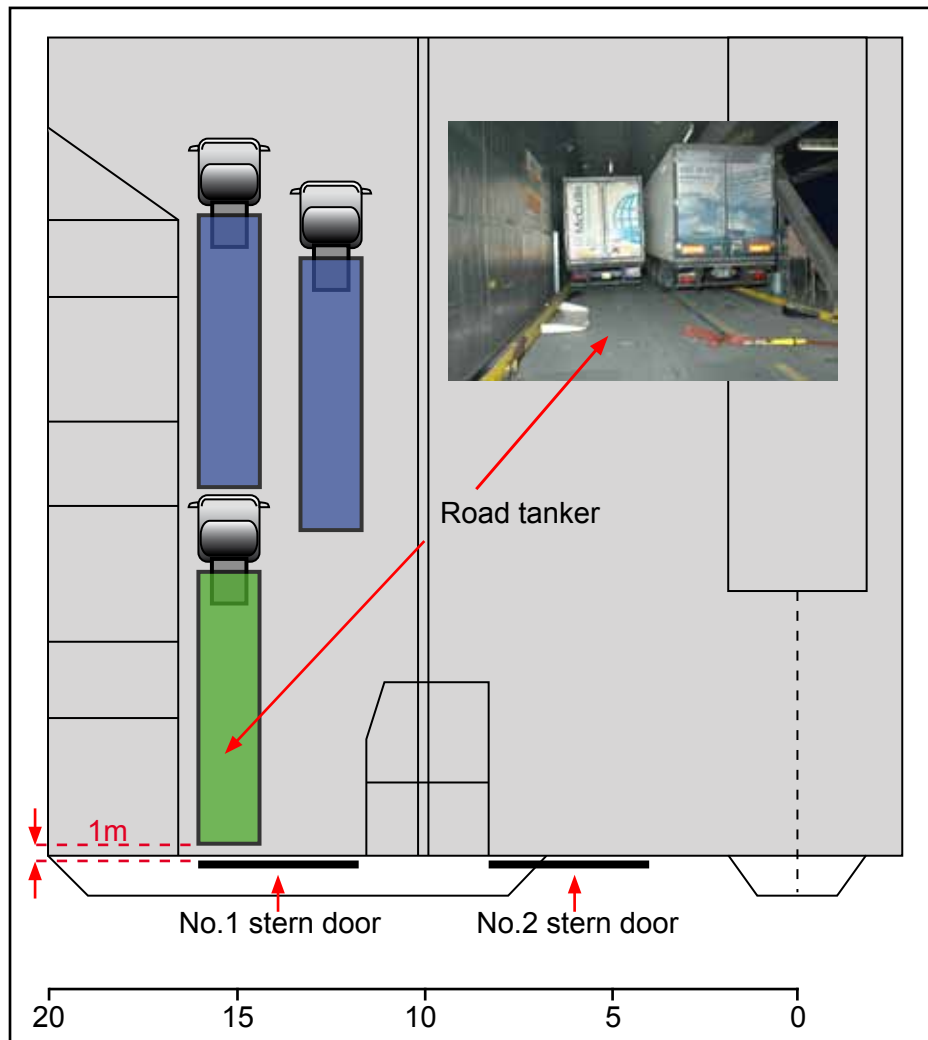
Figure 2

At approximately 2005, the road tanker was marshalled back on board *Stena Voyager* and parked at the aft end of lane number one. The rear end of its semi-trailer¹ was approximately 1m from number one stern door (**Figure 2**). The vessel was now trimmed 20cm by the stern, with a slight port list and a mean draught of 4.8m.

The position of the road tanker at the time of departure

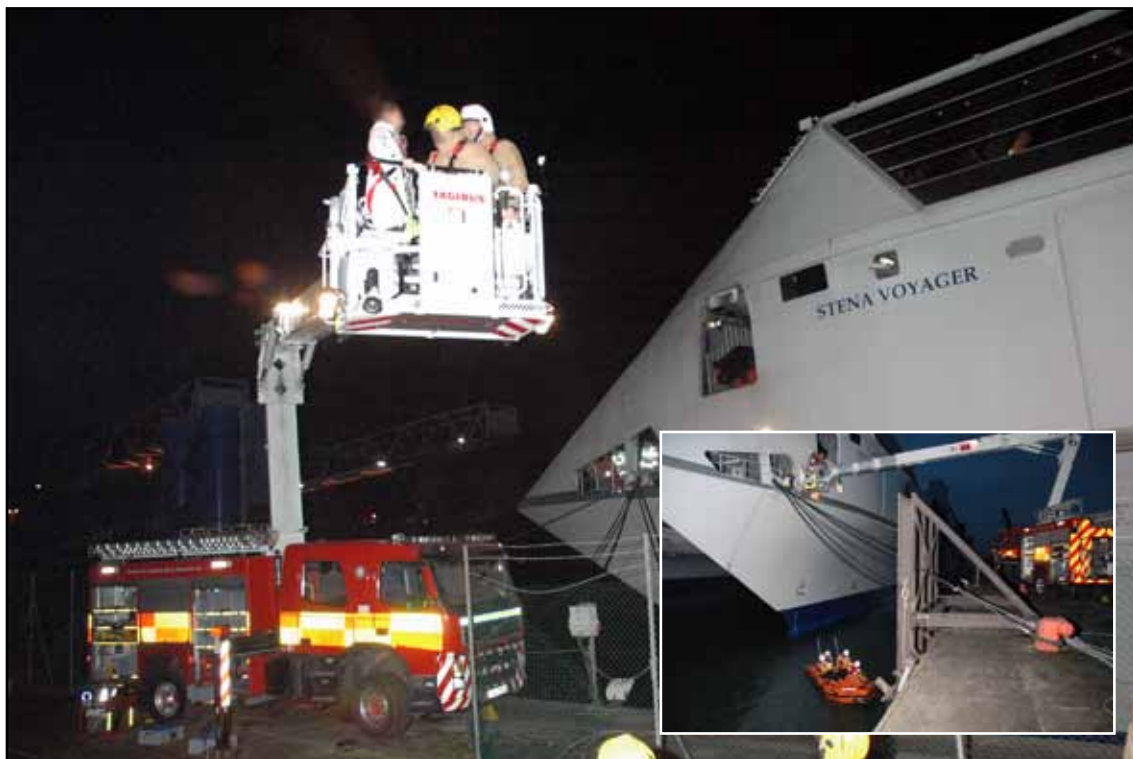
Figure 7

Removal of passengers by the Fire Service

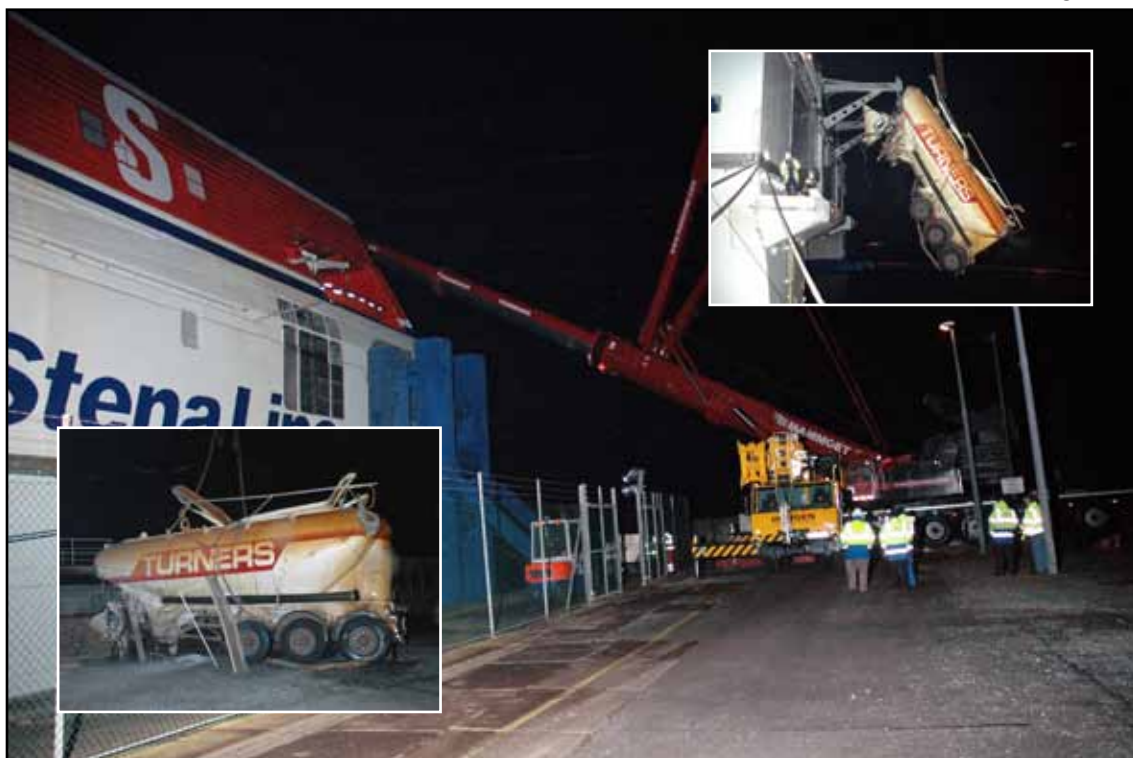
Figure 8

Road tanker recovery

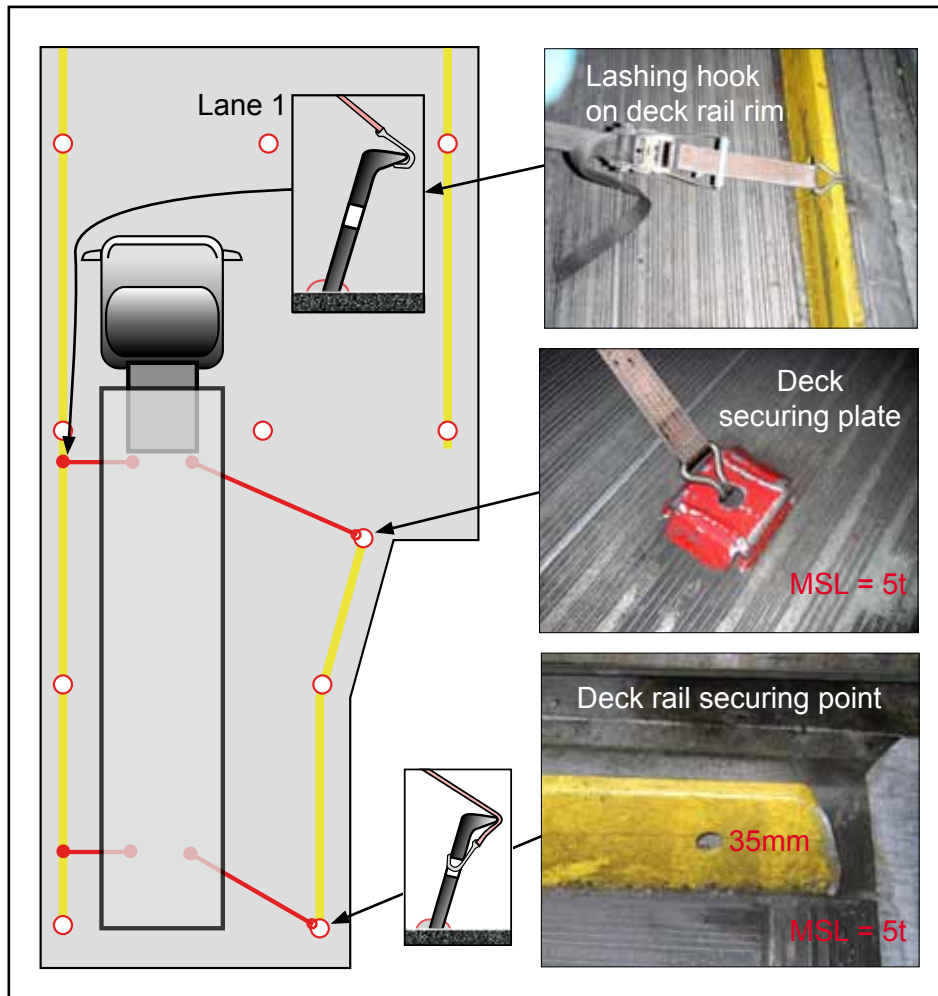
Figure 9

The road tanker was reported to have been secured to the vehicle deck using four web lashings and four rubber wheel chocks. Two lashings were attached to the side impact rails at the rear end of the semi-trailer, and two lashings were attached to ferry securing rings at the front end. The lashing hooks were secured to the deck of the ferry and tightened using their ratchet mechanisms. On the inboard side of the vehicle the forward lashing was attached to a deck securing plate and the aft lashing was attached to a deck rail securing point. On the outboard side, the two lashing hooks were placed on the upper rim of a deck securing rail (**Figure 9**).

Road tanker semi-trailer lashing positions

In this case, the lashings attached to the road tanker were not rigged in accordance with the guidance given in the codes of practice or the instructions contained in *Stena Voyager's* cargo securing manual. Consequently, the two outboard lashings would have provided minimal resistance in either the fore or aft directions as they had been attached to the top rim of the deck securing rail and would therefore have slid along or fallen off the rail as the vehicle rolled along the deck. The inboard lashings provided no restraint against movement in the aft direction; in fact, once tensioned they would have pulled the vehicle towards the stern (**Figure 9**).

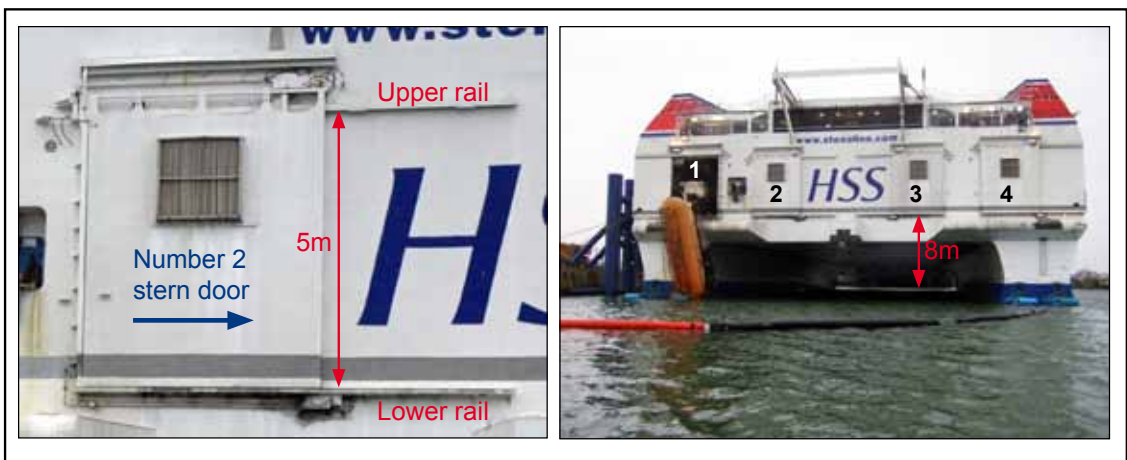
Figure 10

Stena Voyager's main vehicle deck had four lanes, each fitted with a 5m high aluminium sliding stern door at the aft end. The four stern doors were positioned 8m above the waterline and were not classed as watertight (**Figure 10**). Vehicles were driven on board through doors one and two, and off through doors three and four (**Figure 11**). The main vehicle deck had longitudinal serrations to reduce the risk of vehicles sliding from side to side. The area of deck adjacent to number one stern door, where the road tanker was parked, had an anti-slip coating.

Stena Voyager's stern doors

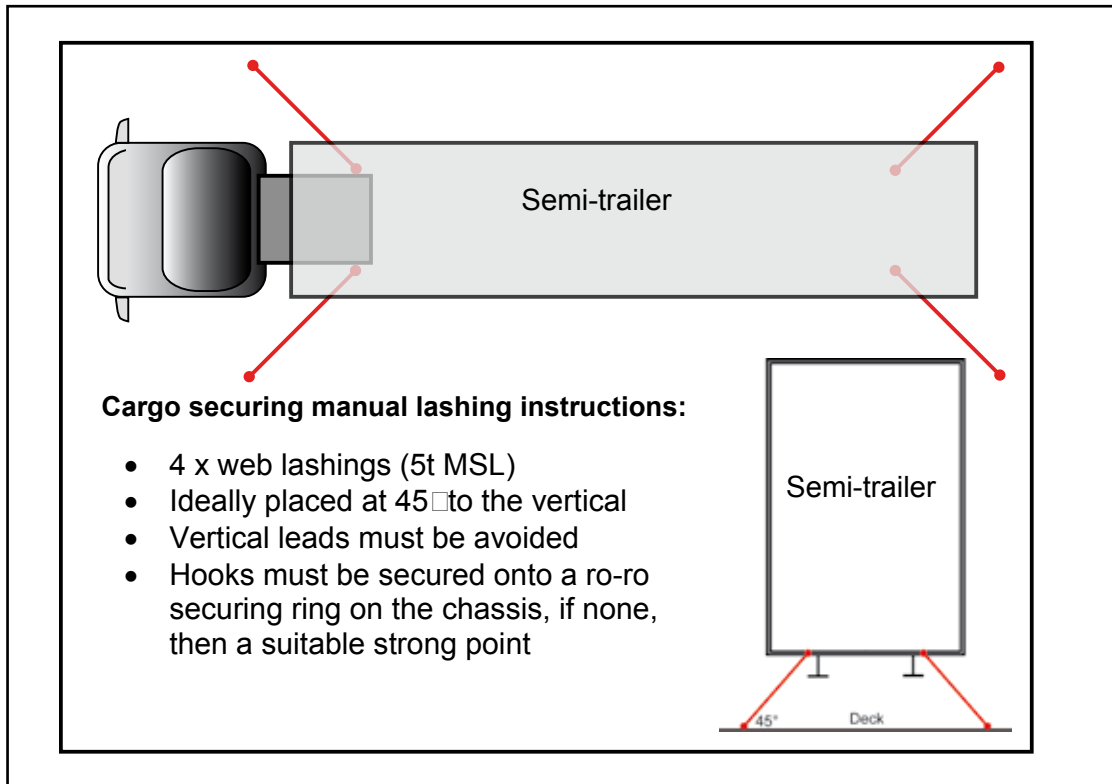
Conventional ro-ro² ferries traditionally use steel chain lashings to secure freight vehicles to the deck. Stena Line used polyester web lashing straps on its HSS 1500 vessels to help protect their aluminium decks. According to the cargo securing manual, the maximum securing load (MSL)³ for the freight vehicle web lashings was 5t. The freight vehicle lashings used on board *Stena Voyager* were 3.5m long and had a minimum breaking strength of 5t. They had a stainless steel securing hook at each end and were tensioned by a manual ratchet mechanism. The lashings were not individually marked and were not given a maximum working life. The onboard maintenance regime was limited to periodic visual inspections. *Stena Voyager's* cargo securing manual required the road tanker's semi-trailer to be secured to the deck using four web lashings (**Figure 14**).

Lashing arrangement prescribed in *Stena Voyager's* cargo securing manual

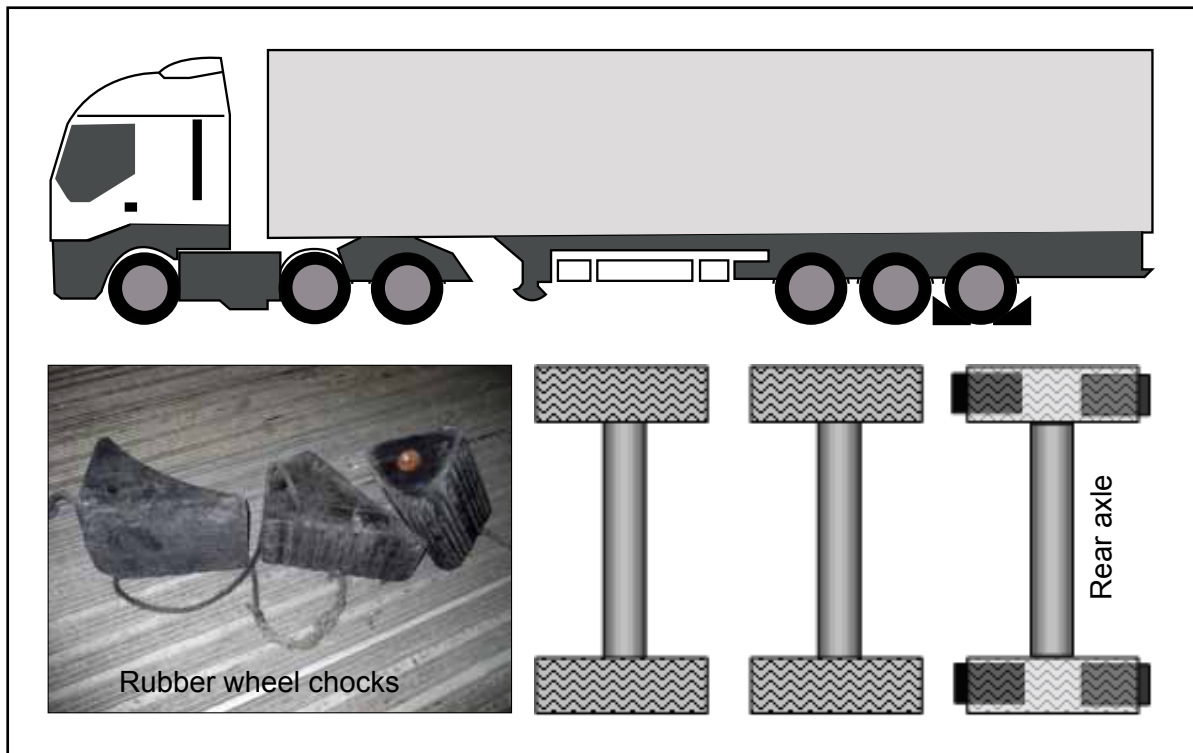
Stena Line used rubber wheel chocks to supplement the freight vehicle lashings on board the HSS 1500 vessels. Three different types were used on board *Stena Voyager*. The approved procedure was to place four chocks around the freight vehicle's rear wheels, two facing forward and two facing aft (**Figure 15**).

Stena Voyager chocking arrangements

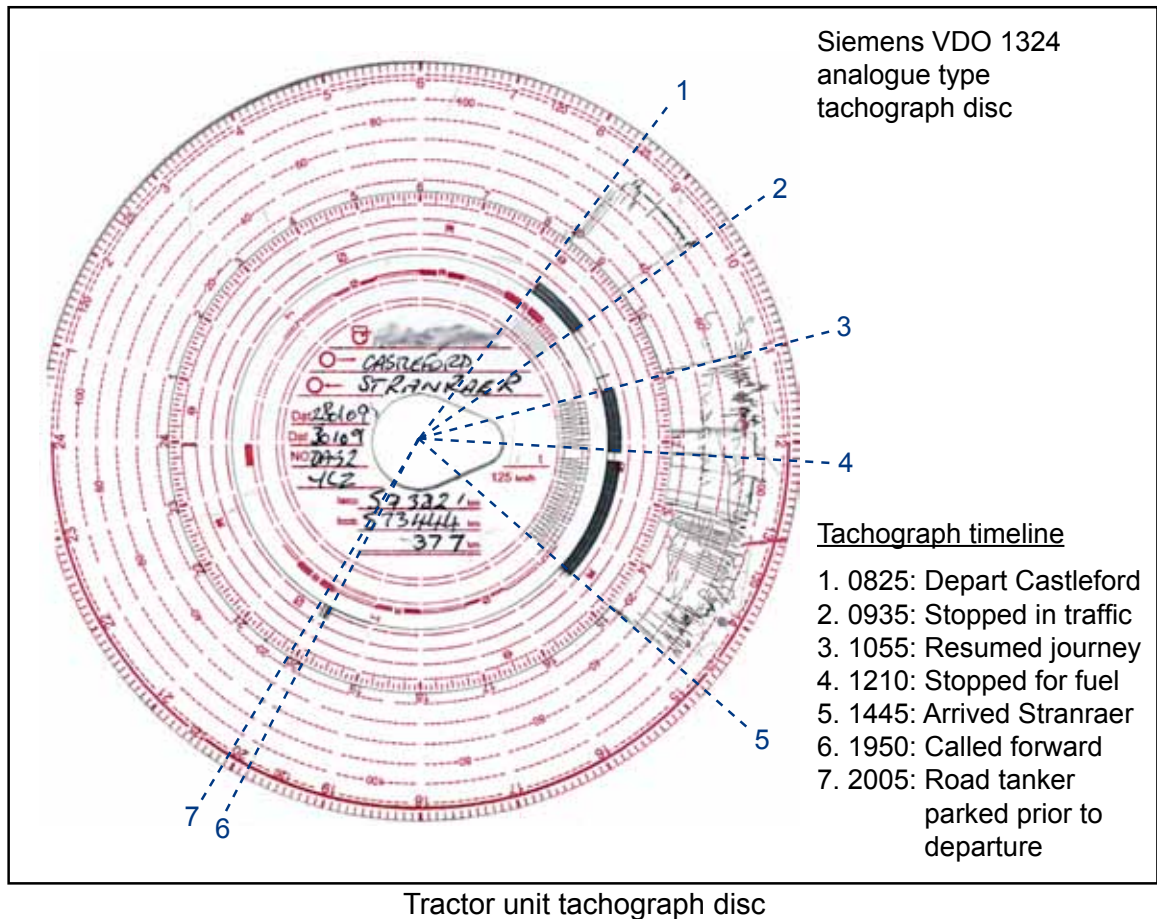
The tractor unit was fitted with a Siemens VDO 1324 analogue type tachograph. The tachograph is a precision instrument which records the speed of the vehicle and the distance travelled, on a circular chart (**Figure 18**). The circular chart covers a 24 hour period and is renewed daily.

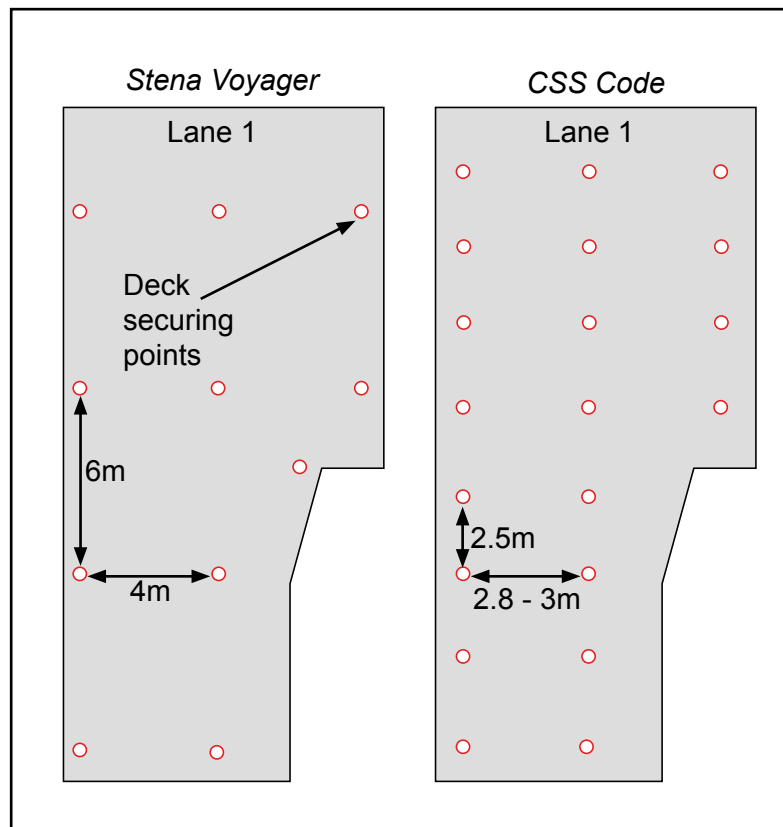
Figure 22

The resolution states the arrangement of deck securing points should be left to the discretion of the shipowner provided the minimum distance between them in the fore and aft direction does not exceed 2.5m and the athwartships spacing is between 2.8m and 3m (**Figure 22**). It also states that securing points on road vehicles should be designed for securing the road vehicle to the deck of the ship with no fewer than two, and no more than six securing points on each side of the vehicle. These guidelines apply to road vehicles, with the exception of

Deck securing point spacing

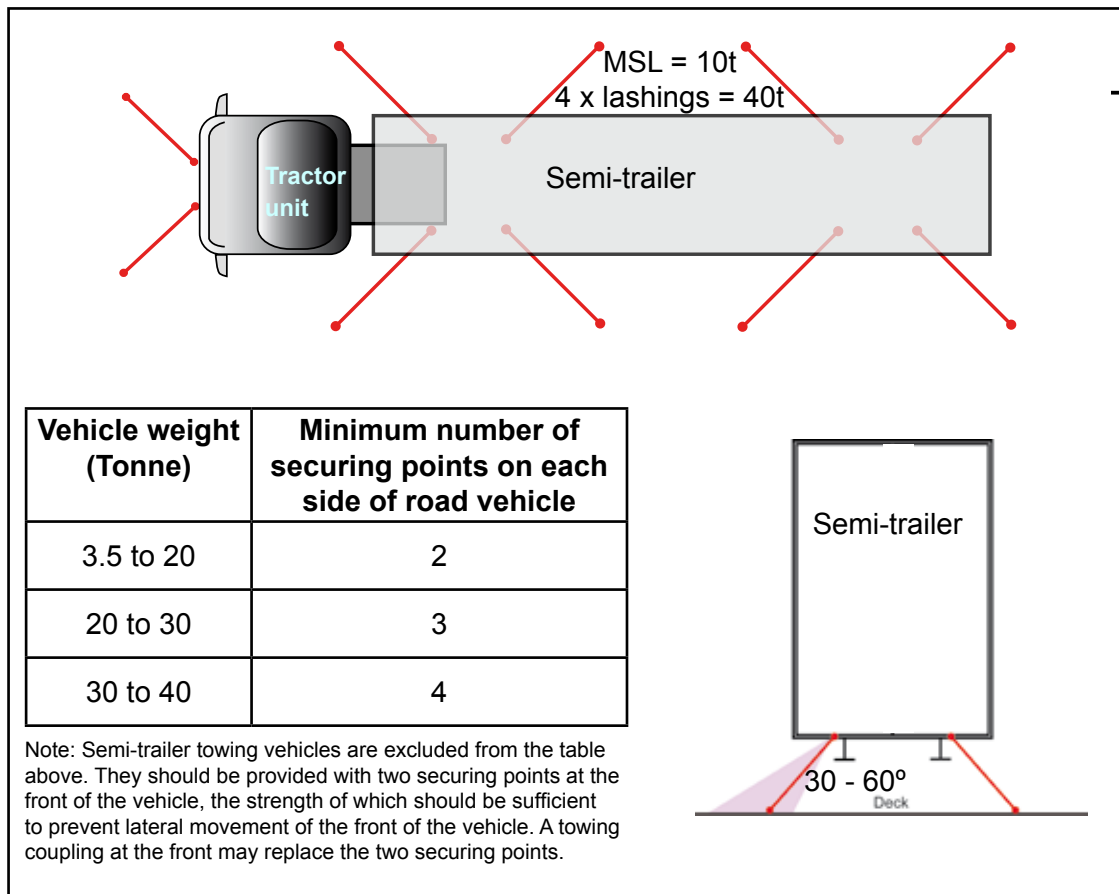
Figure 23

buses, weighing 3.5t and over. The total number of securing points on each side of a road vehicle is dependent on its weight. As a rule of thumb, the total MSL values of securing devices on each side of a unit of cargo (port and starboard) should equal the weight of the unit (**Figure 23**). Other guidance given in the resolution includes:

CSS Code ferry securing ring guidance
